Kneller Hall

Heritage Assets Assessment

Prepared for LB of Richmond upon Thames

April 2020

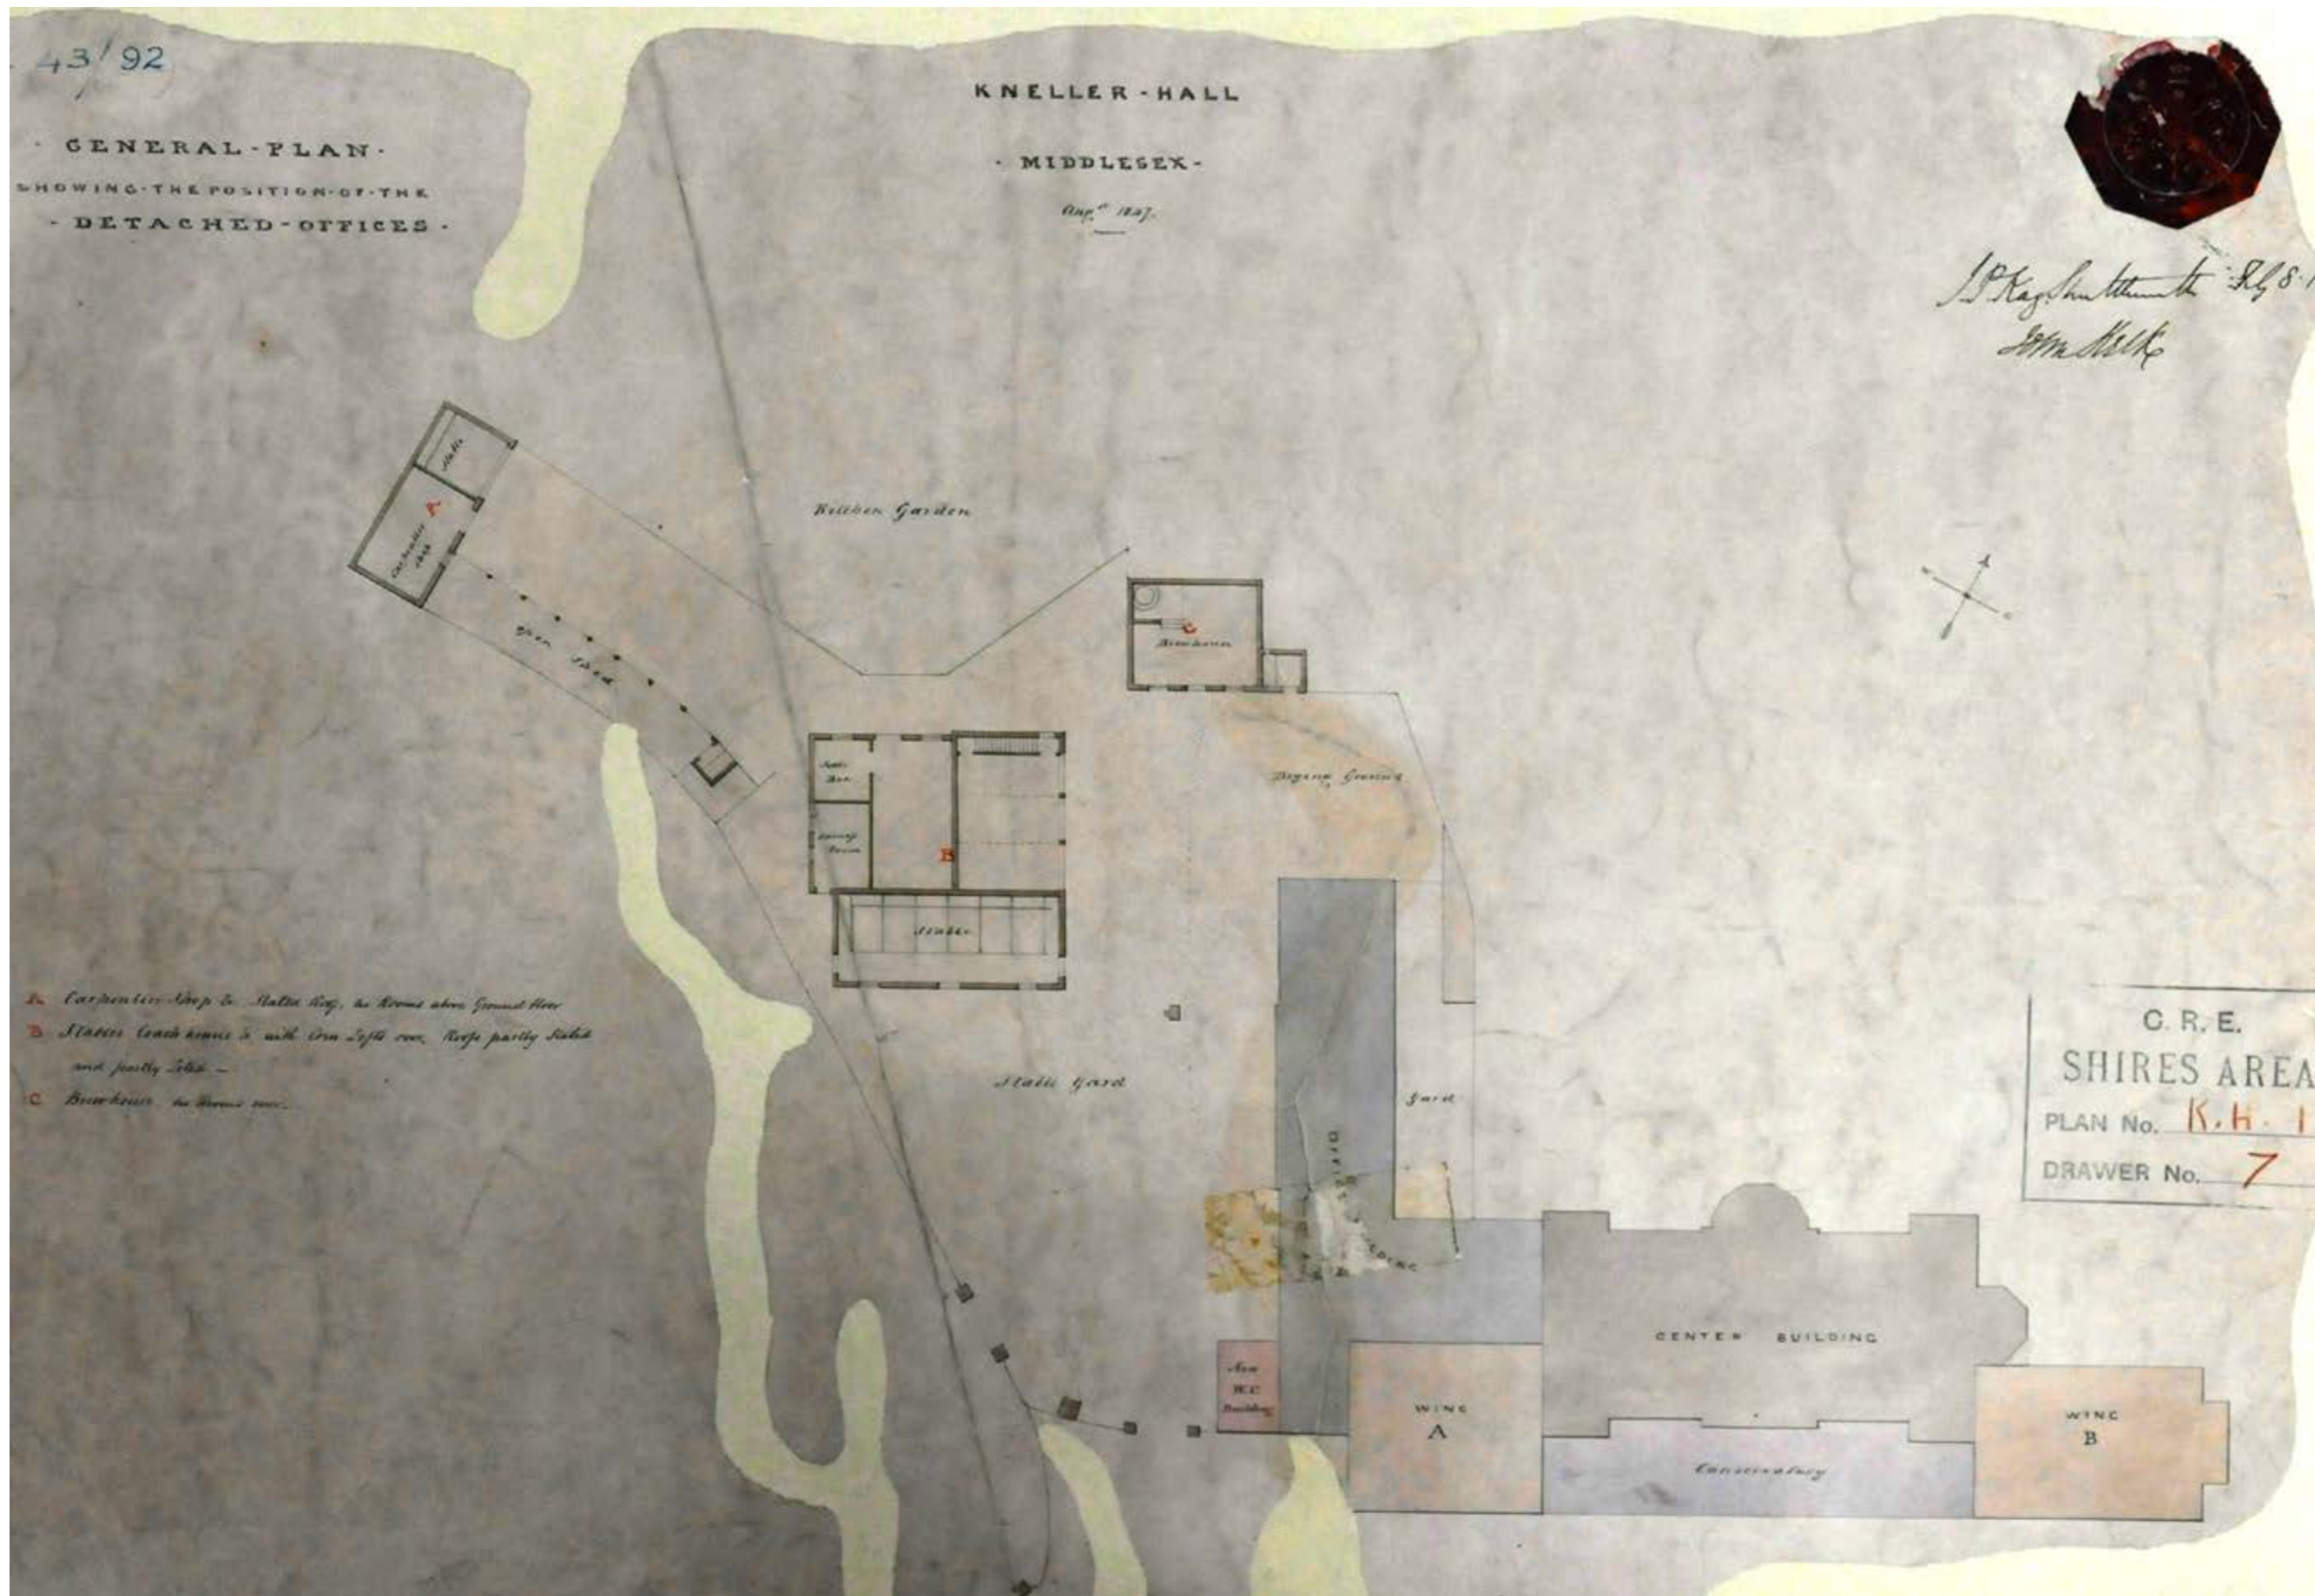
Figure 8: 1847 site plan showing the existing building divided into its various sections and the three outbuildings to the northwest

When the 1847 – 49 developments were proposed, the central block (the only remaining section of Sir Godfrey Kneller’s original house) was found to be structurally unsound. It is likely that Figure 7 on page 9 represents the initial design proposal prior to this discovery.

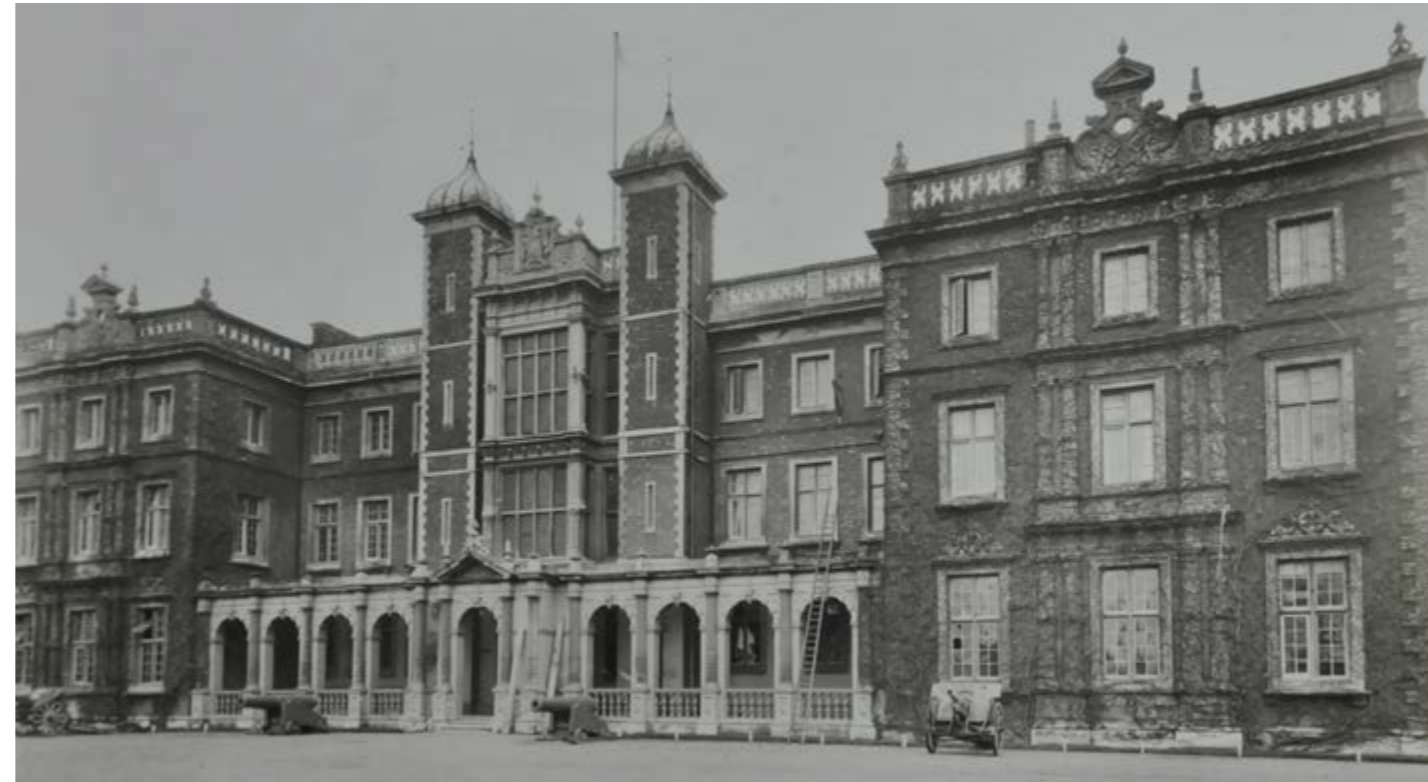
Figure 17: Front elevation as captured by the stonework inspector in 1921

In the 1920s, Kneller Hall's stonework was in poor condition and a survey was commissioned to assess the extent of damage and to make recommendations for its restoration. Restoration of the exterior stonework of the building was carried out again in 1990 by Calder Ashby surveyors and was undertaken to the designs inferred from engravings and photographs in the absence of access to original drawings (*Building* 1990).

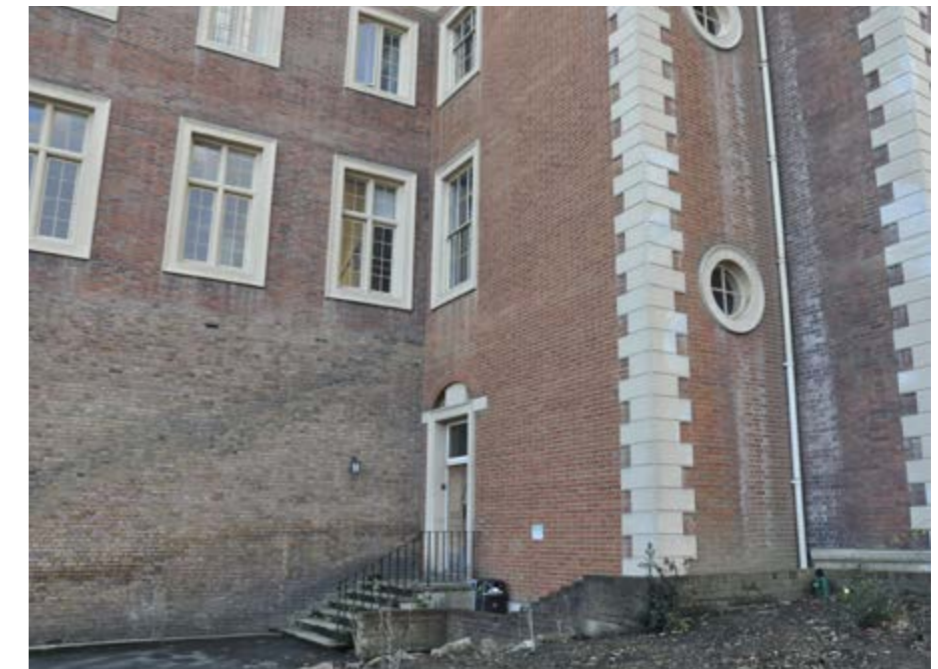
Figure 19: Additional section built to the north of the eastern wing in c.1970 to accommodate a new stairwell

The pair of staircases to the north of each of the building's wings appear, based on internal fabric, to have been added in c.1970. In the case of the western staircase, this was built within the existing northwest wing, but the eastern staircase involved the removal of an 1848 oriel window and the construction of an additional section, built to mimic the 1848 design of the main house.

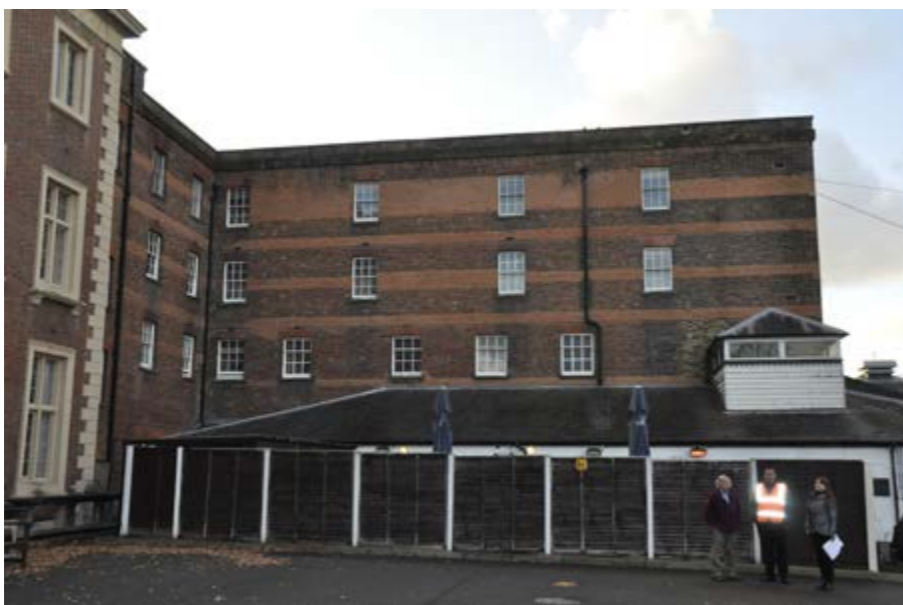
Figure 37: View of northwest wing from the east, showing the patched brickwork and the subsidiary building in front

The west elevation is of **high significance** for its historical value. Despite having historically housed ancillary spaces of less architectural interest, the wing is the earliest surviving fabric within Kneller Hall, though the patching in the brickwork suggests there have been multiple interventions over time.

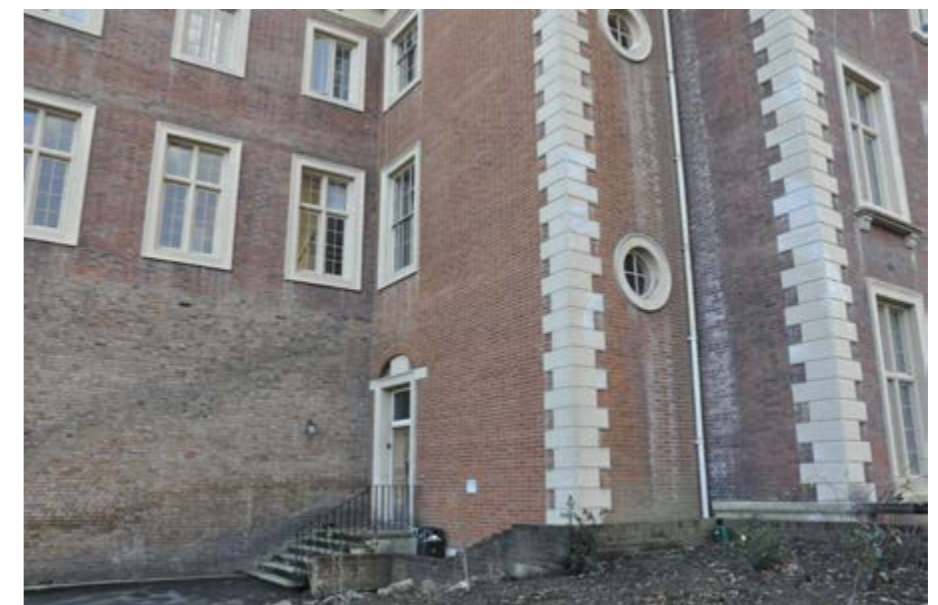
Figure 39: Exterior of 1970s staircase extension

The east elevation is of **high significance** for its aesthetic and historical value, with the exception of the 1970s stairwell addition which is of **neutral significance**.

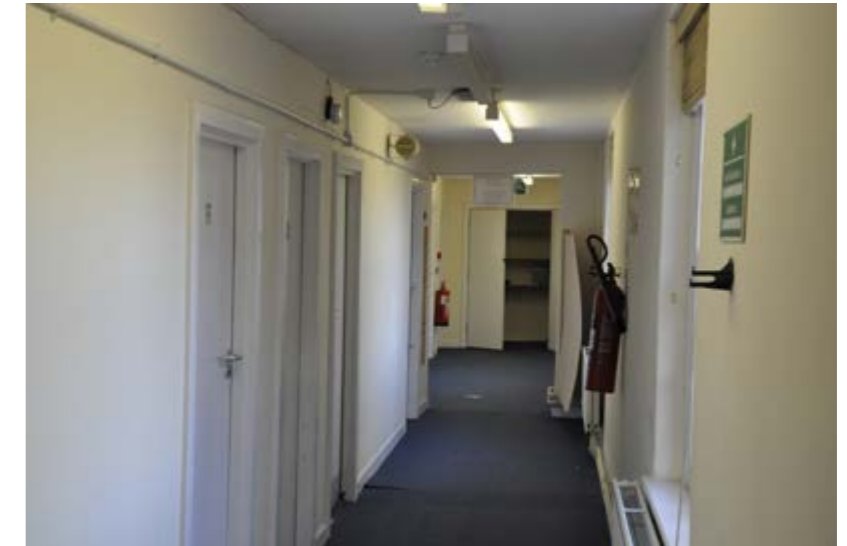
Figure 52: Partitions at second floor

As described above, the mezzanine, second floor, and the north end of the first floor are not currently in use. In these areas, heavy blockwork partitions have been built up off the original timber floors. The timber floors in these areas are sagging considerably. In these areas, the blockwork partitions should be removed and opening up works should be carried out to confirm the condition of the timber floors. It is likely that significant repairs to the timber floors will be needed. Repairs are also likely to be needed to decayed timber joists where they are in contact with damp external masonry walls.

The defects noted can generally be addressed as part of the next refurbishment. However depending on when this is carried out, it may be sensible to remove the partitions in the West Wing to mitigate further deterioration of the timber floors. It would also be sensible to address the faulty rainwater goods and below ground drainage to mitigate further deterioration.

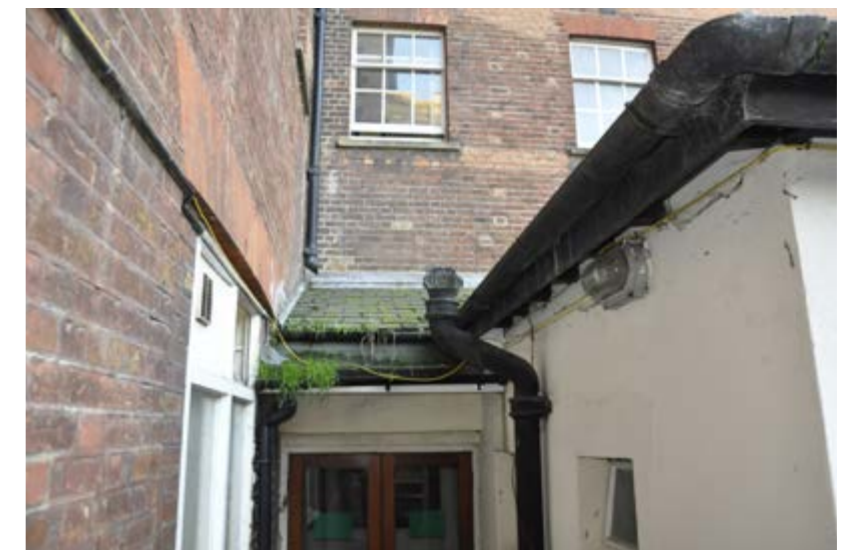
Figure 53: Blocked rainwater goods

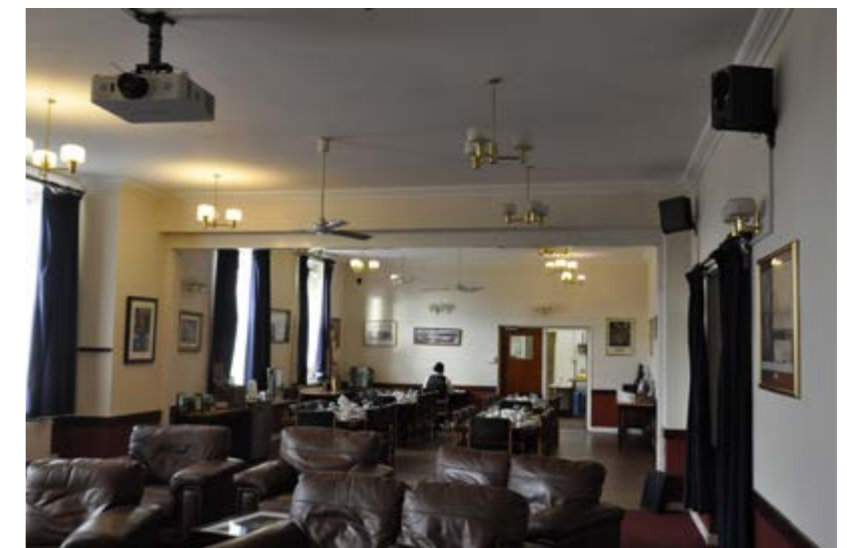
Figure 54: Open plan ground floor

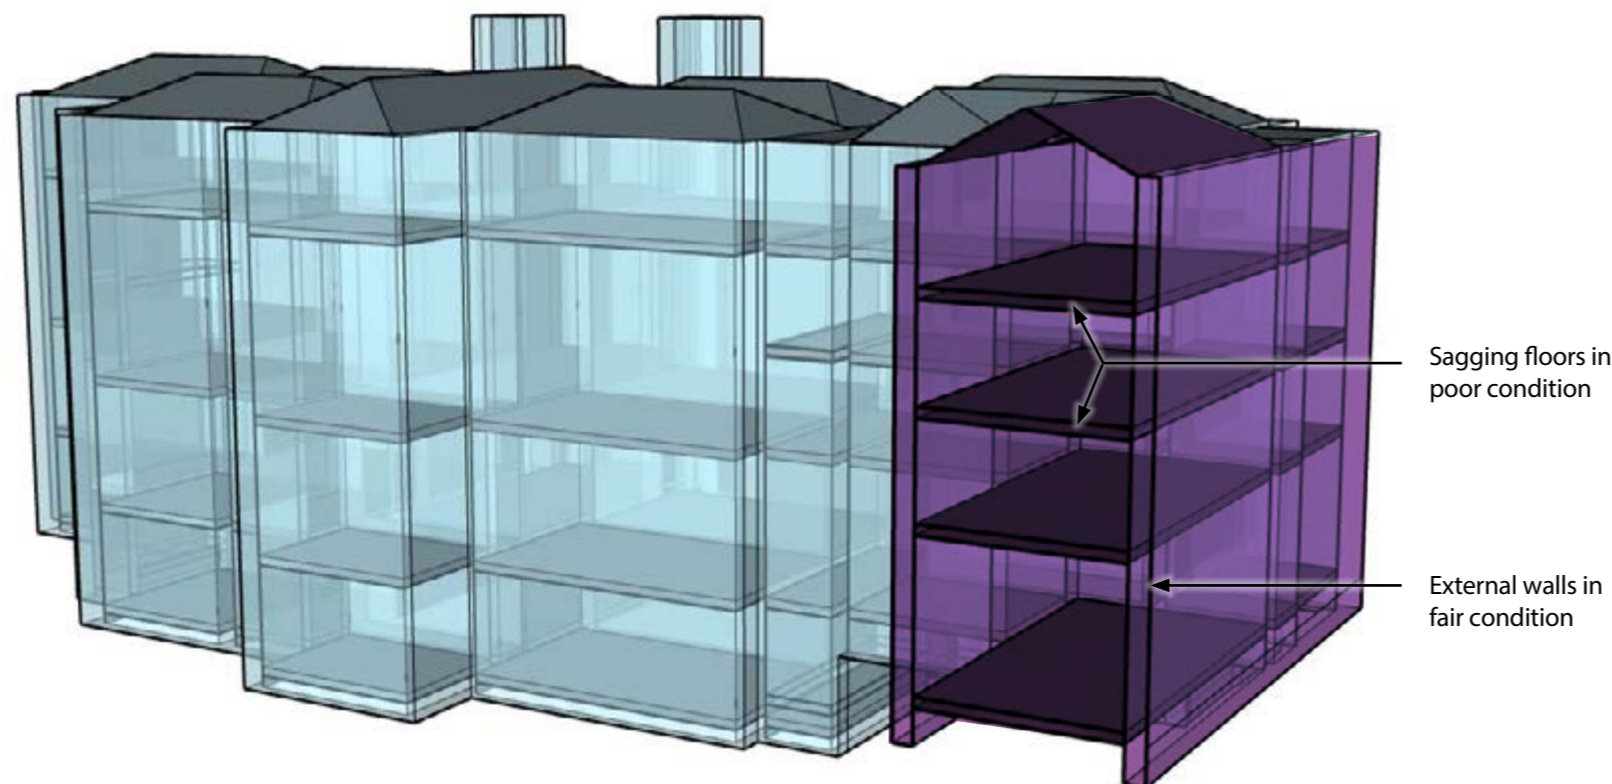
Figure 51: Section diagram of Zone 1

Generally the original quality of the construction of Kneller Hall is of a high standard. However historic alterations to the original structure have in some cases been poorly conceived. In particular the upper floors of the West Wing (Zone 1) have been closed off due to concerns about their structural condition as a result of previous inappropriate alterations. These will be discussed in further detail below. The other areas are generally in a reasonable condition for a building of this age and type.

The external walls in the north-west corner of the wing are bulging. It is likely, based on our observations that the facing brickwork is delaminating from the rest of the wall behind. This is particularly noticeable on some of the window reveals where there is cracking in the brickwork. Elsewhere there are other local defects to the elevation that will need to be addressed.

We noted a number of areas where rainwater goods are blocked and these should be cleared to mitigate further water ingress into the structure of the building. The current issues with water ingress mean the timber roof members are likely to be decayed in these areas and repairs may be needed to these.

We have not accessed the main roof of the west wing. Repairs to the roof should be allowed for where rafters are in contact with damp external masonry at eaves.

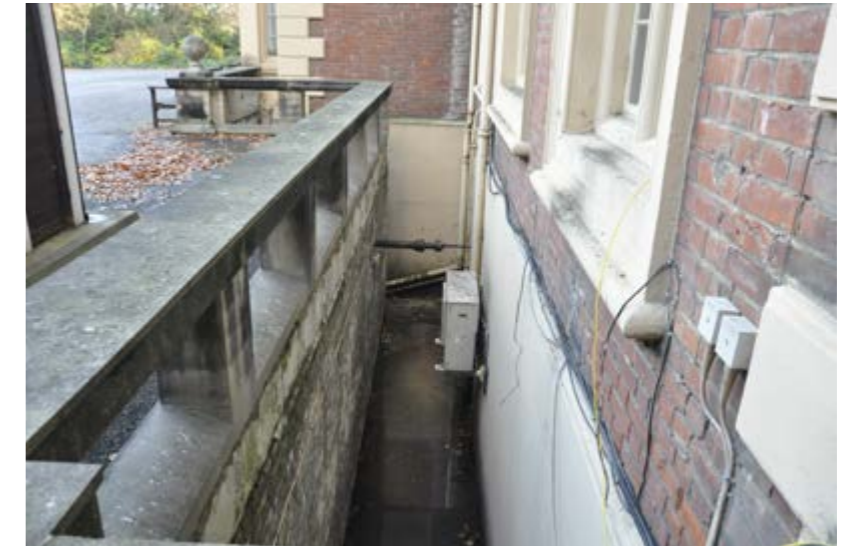
Figure 56: Blocked drainage network at northern lightwells

At basement level, the areas we accessed were generally in a reasonable condition, apart from the lightwells and basements which project beyond the footprint of the building. These areas are suffering from water ingress and damp. We noted standing water in the northern light-wells which suggests the below ground drainage system is defective. The below ground drainage in this area should be jetted and cleared and a CCTV survey should be carried out to confirm its condition. An allowance should be made for repairs to the below ground drainage in this area.

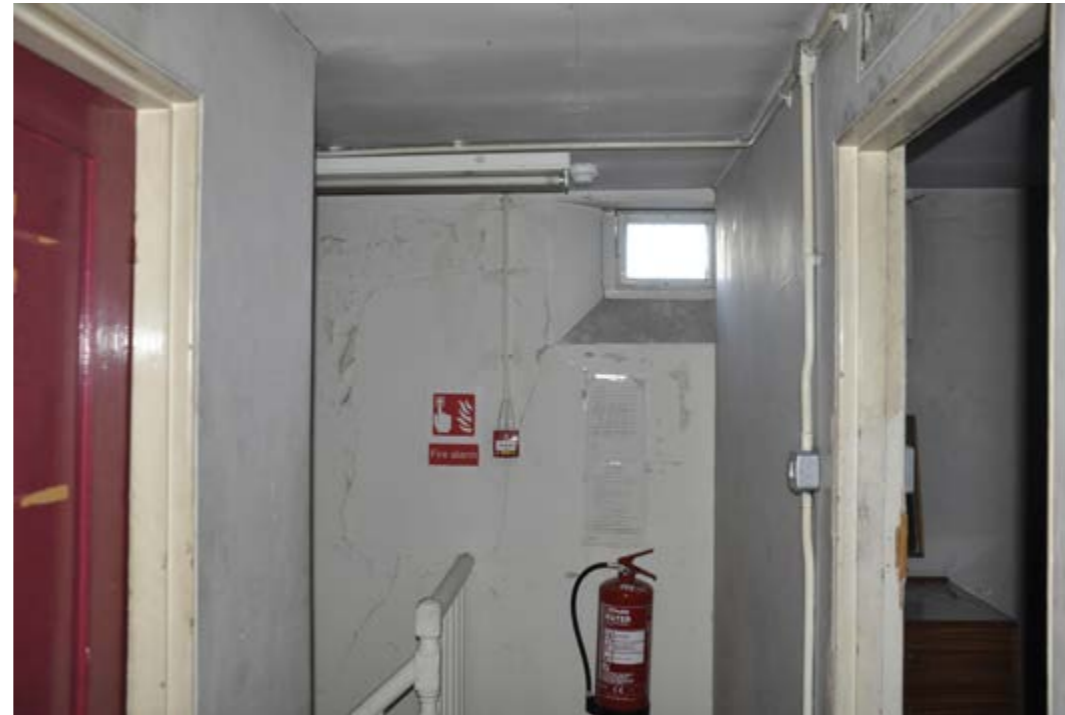
Figure 58: Signs of water ingress in the loft

This area is generally in a good condition for its age and type of construction. We noted that the loft rooms (T01 to T04) showed signs of water ingress and minor cracking to plaster. Repairs to decayed roof timbers should be allowed for in this area similar to Zone 2.

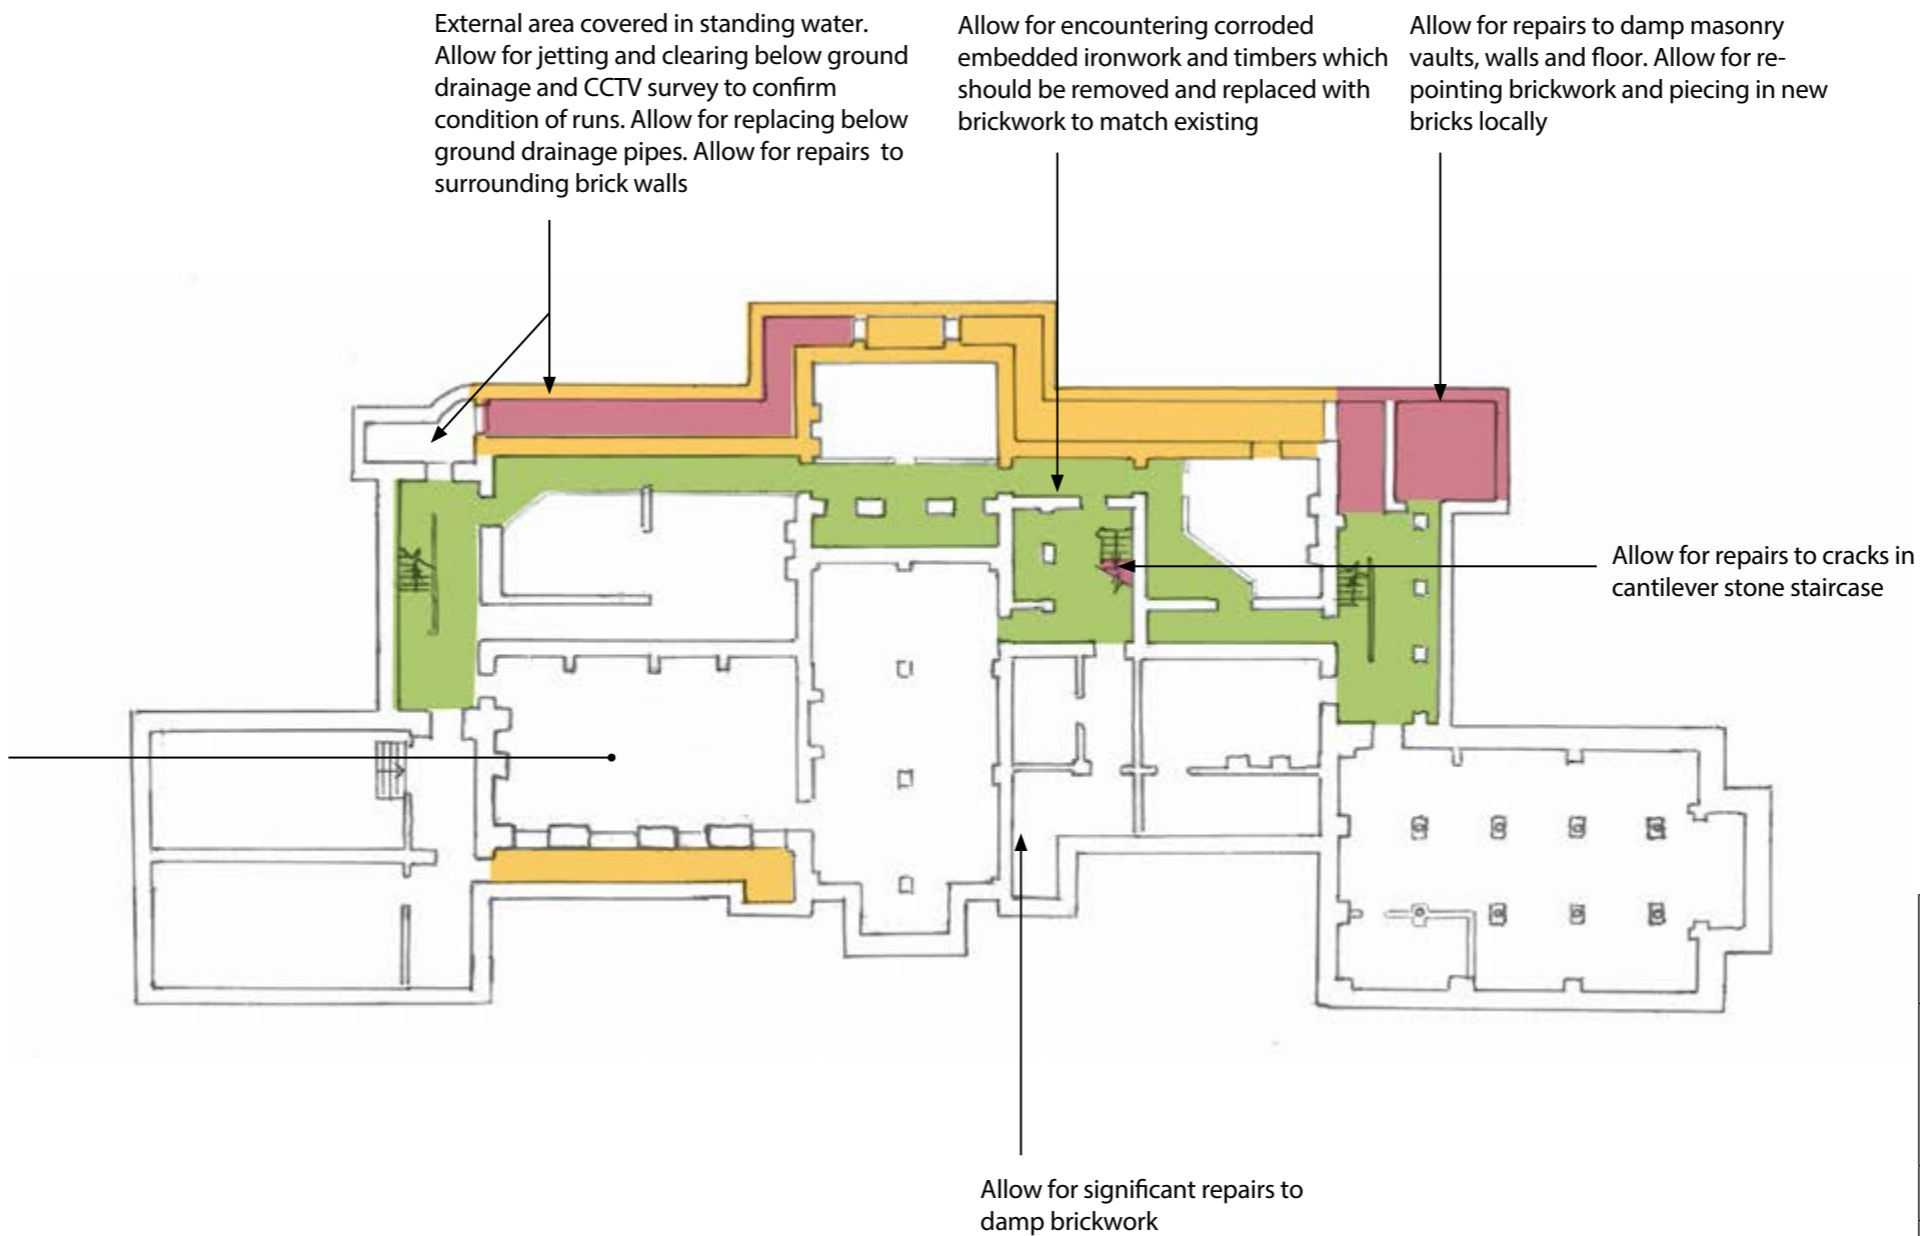
KNELLER HALL HERITAGE ASSETS ASSESSMENT	
SUMMARY OF STRUCTURAL CONDITION AND REPAIRS BASEMENT LEVEL	
1875/30 / SK01	
DECEMBER 2018	Alan Baxter

Condition and likely repairs in areas not accessed to date:

- allow for local repairs and re-pointing to damp masonry
- allow for repairs to damp perimeter retaining walls

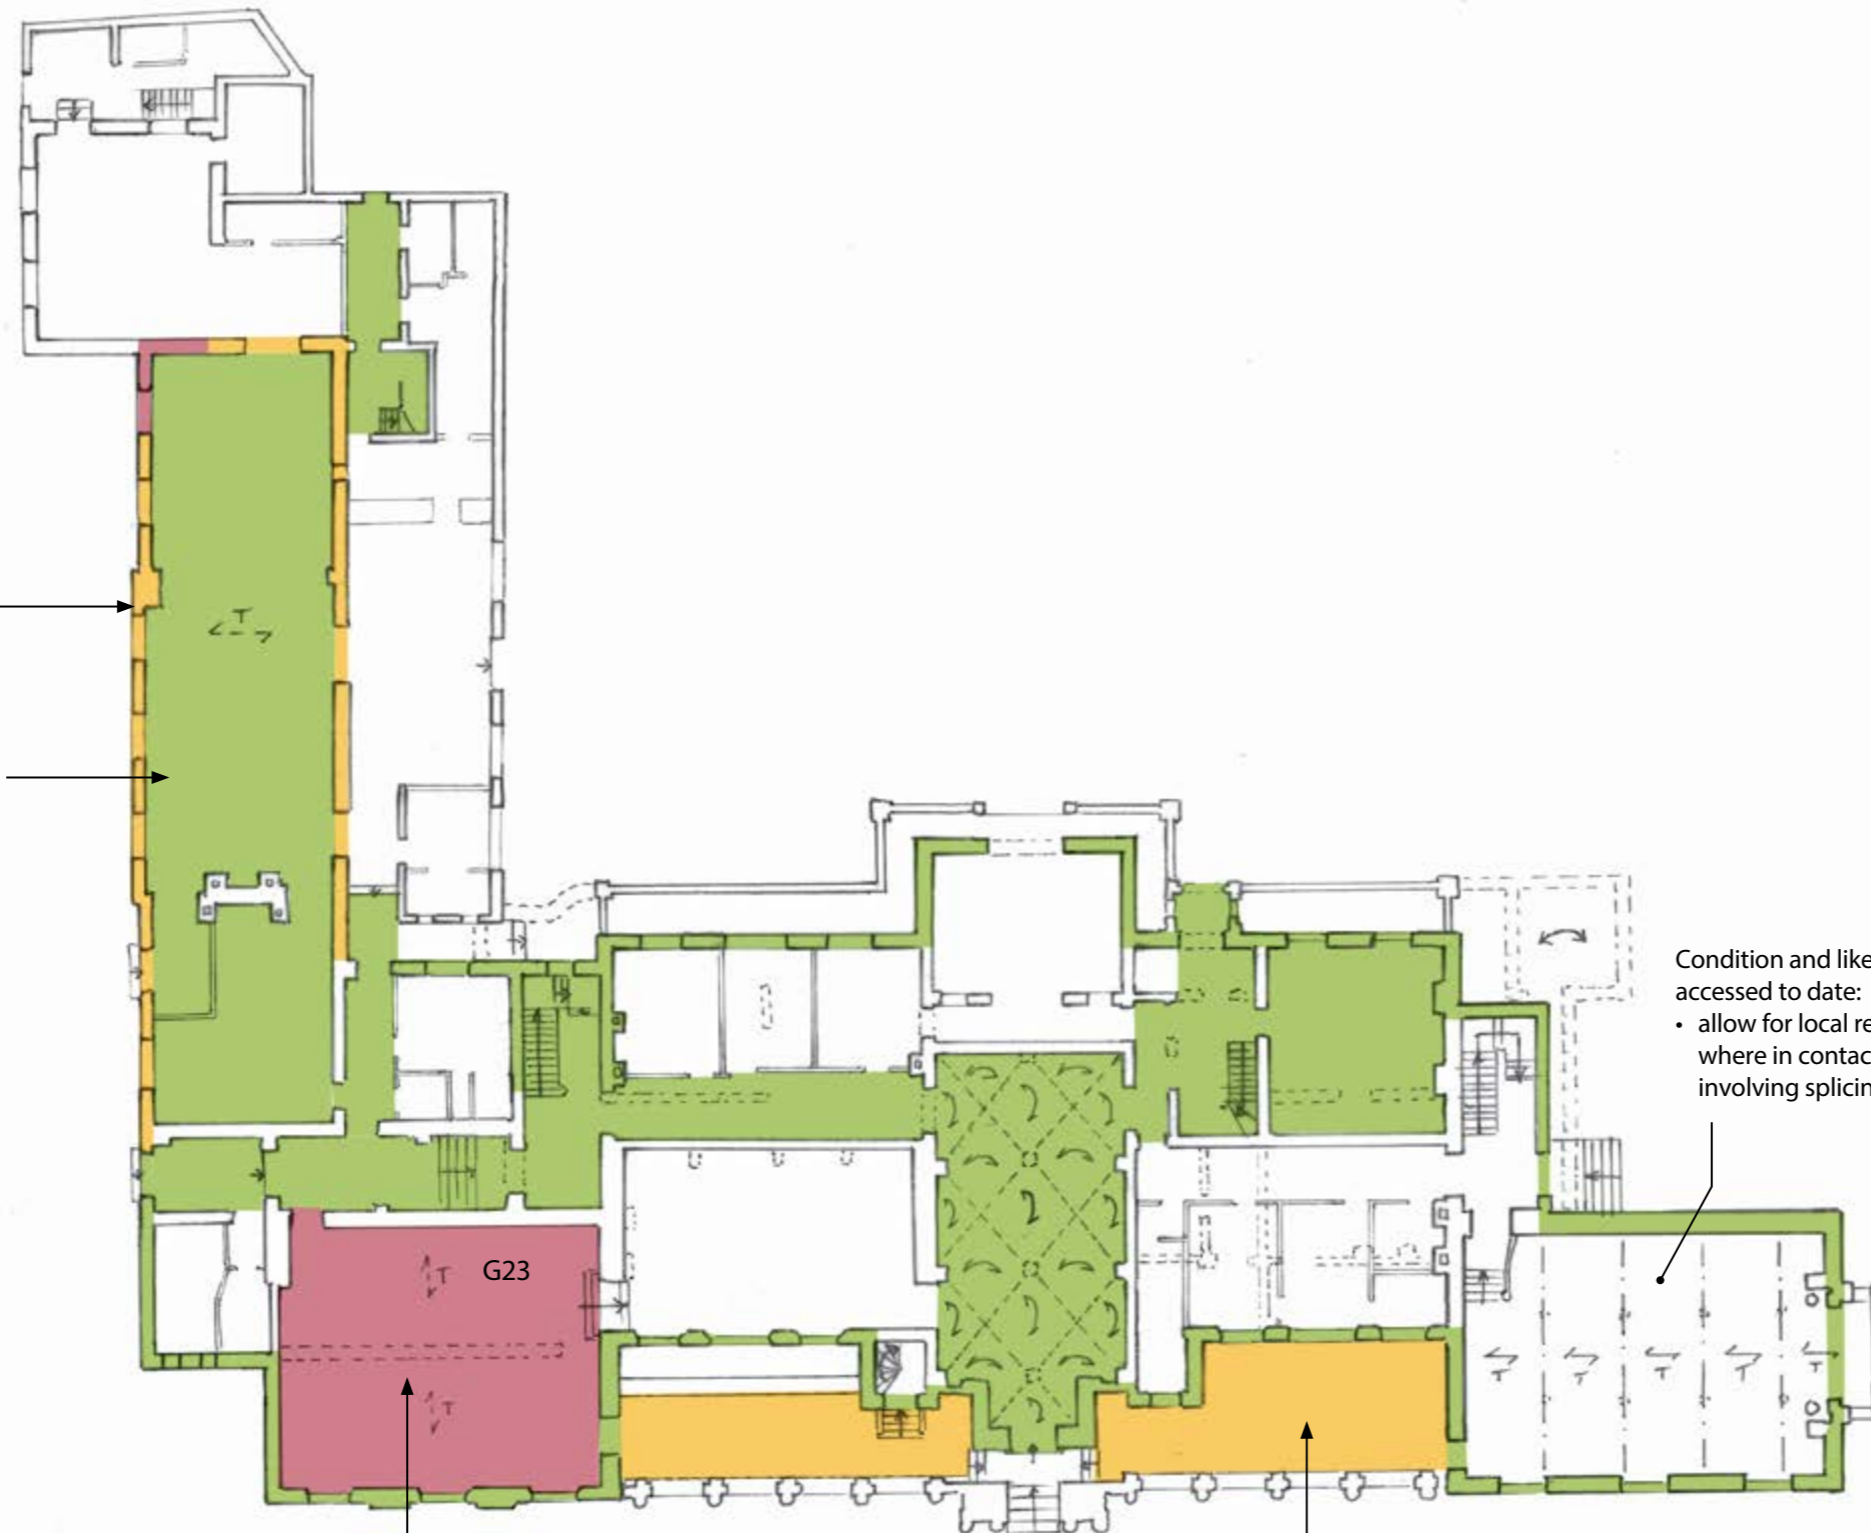
Allow for repairing local defects to external walls. Allow for replacing decayed timber lintels with pre-cast concrete lintels (~10%) and allow for local brickwork repairs

Allow for repairs to timber floors where in contact with damp masonry involving splicing joists ends

Condition and likely repairs in areas not accessed to date:

- allow for local repairs to timber floors where in contact with damp masonry involving splicing joists ends

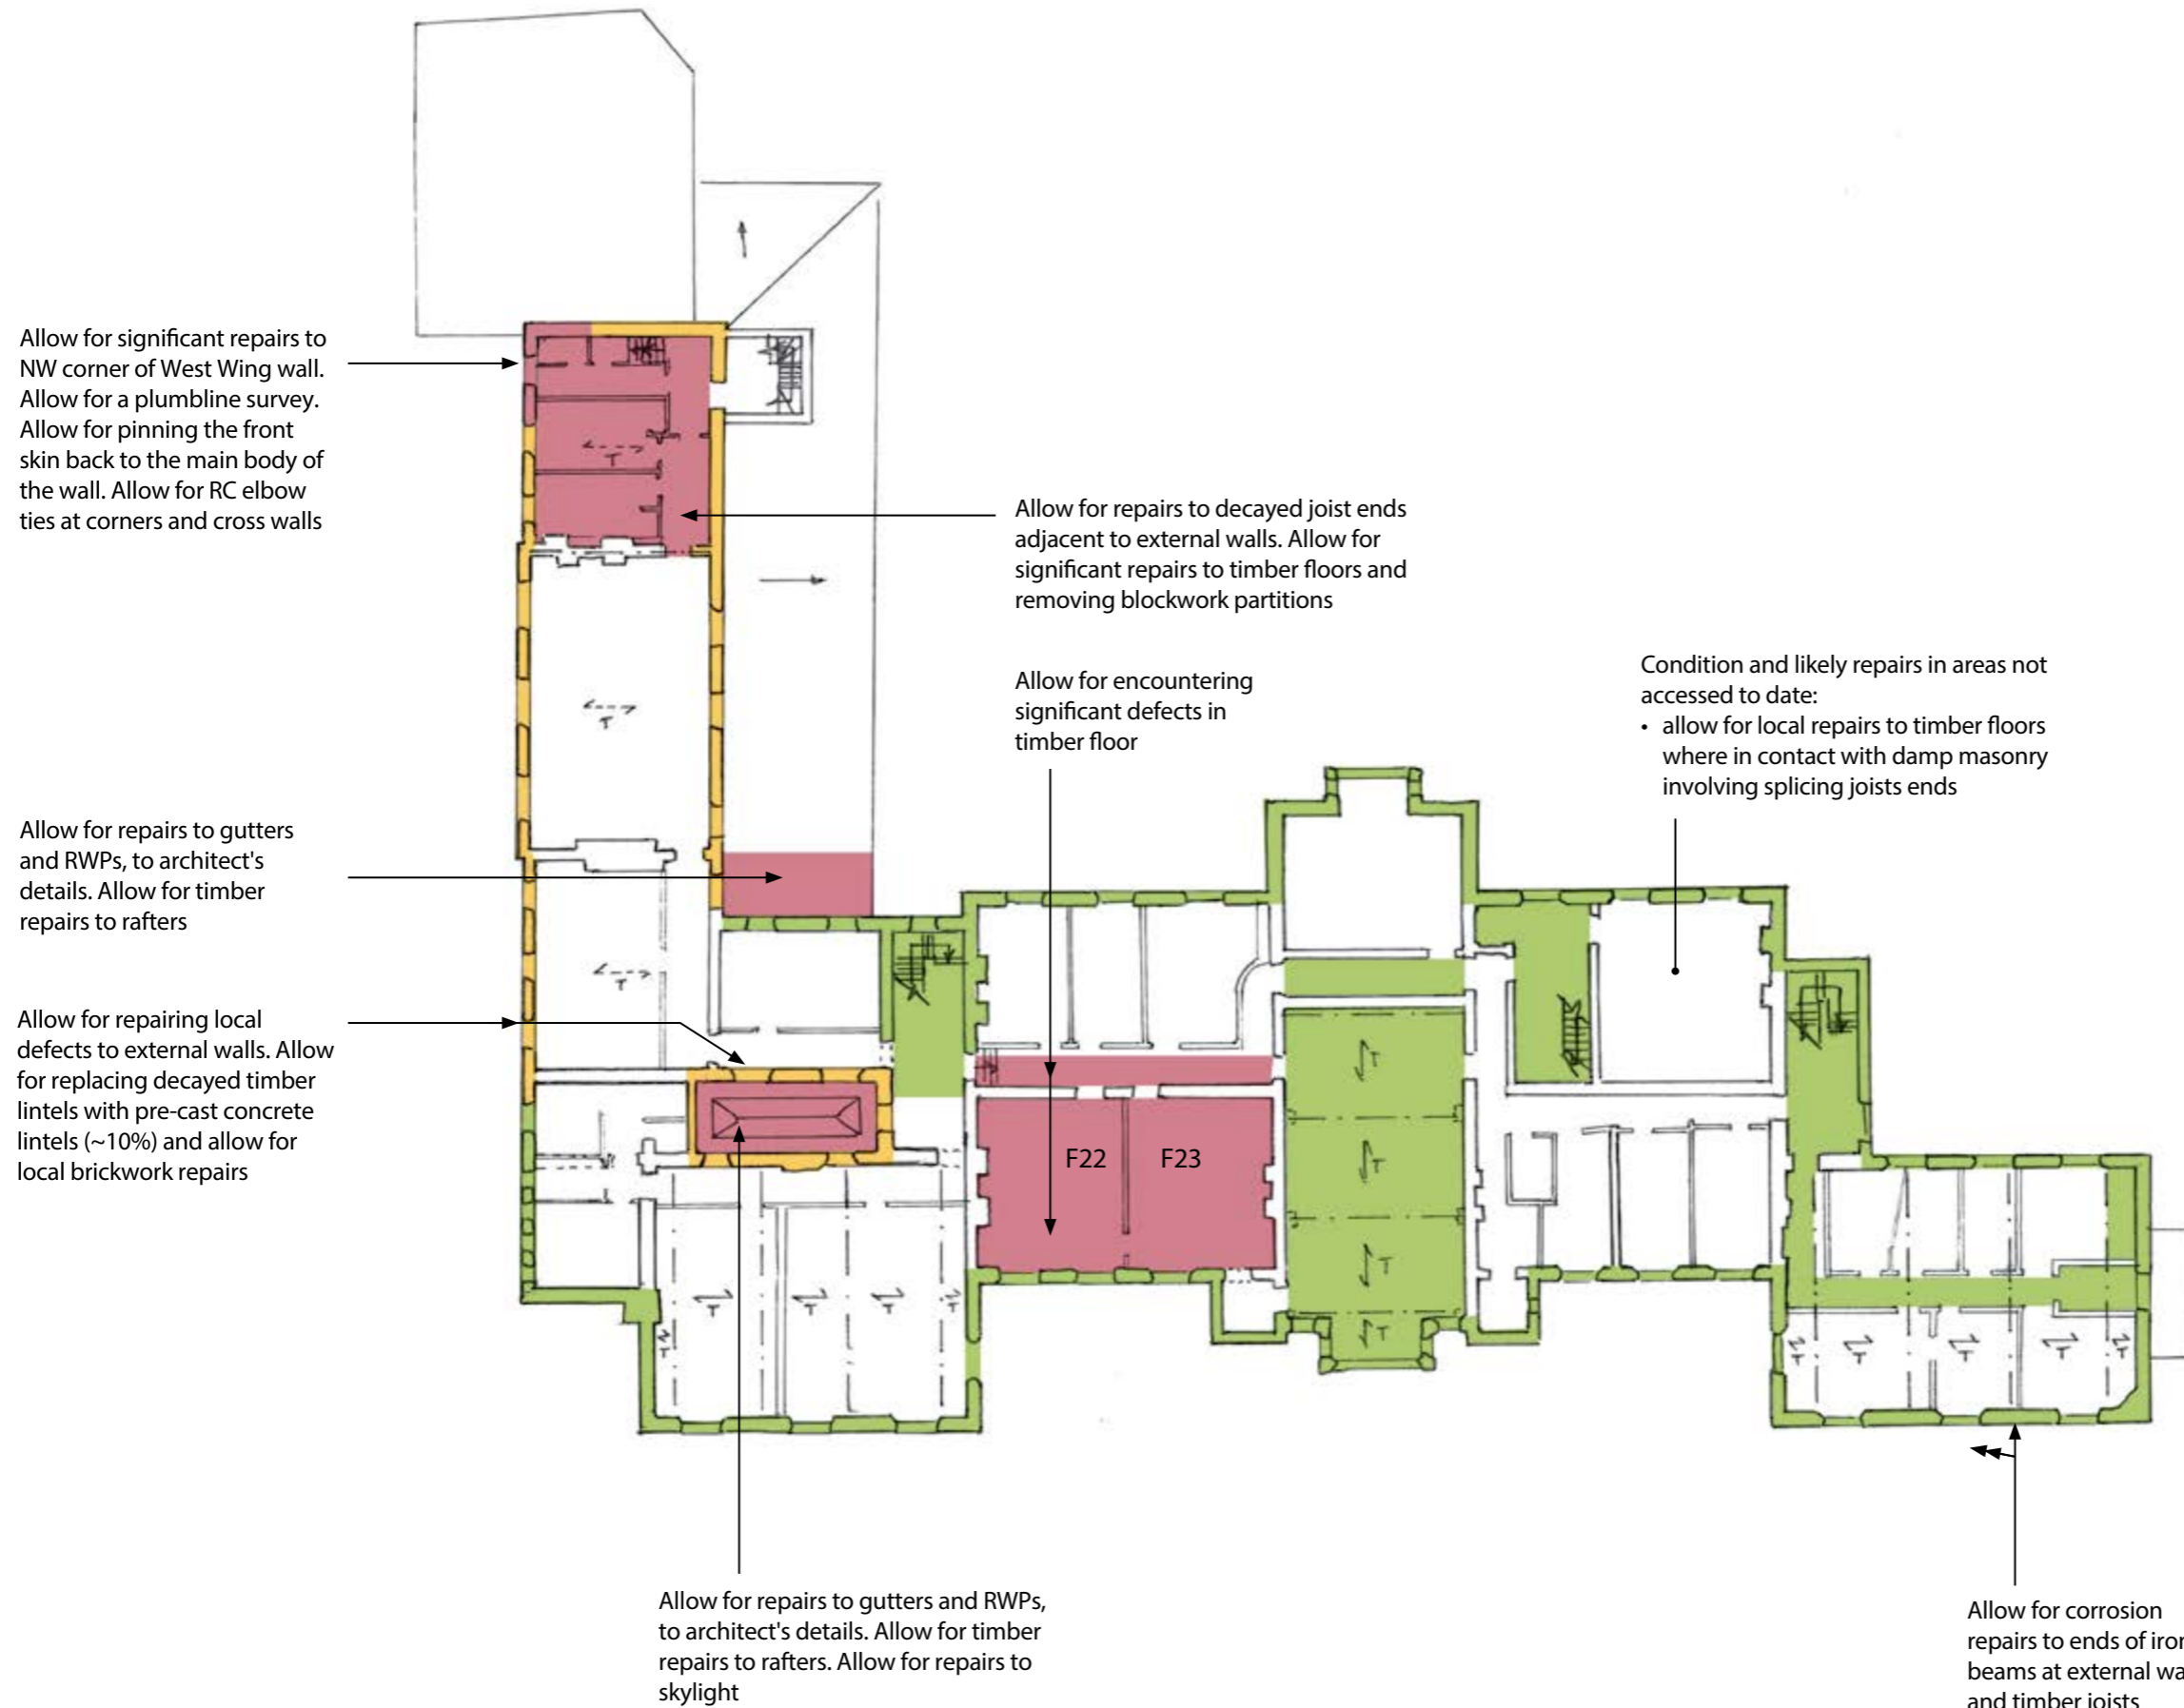
KNELLER HALL HERITAGE ASSETS ASSESSMENT	
SUMMARY OF STRUCTURAL CONDITION AND REPAIRS FIRST FLOOR LEVEL	
1875/30 / SK03	
DECEMBER 2018	Alan Baxter

- Structure in reasonable condition
- Structure in fair condition
- Structure in poor condition
- Areas that are not coloured have not been seen by us during our visit
