# **HAMMERSMITH TEMPORARY FERRY**

## **LANDSCAPE AND EXTERNAL DESIGN & ARBORICULTURAL ASSESSMENT**

**AUGUST 2021**  
2048-BRL-02-XX-RP-C-1700

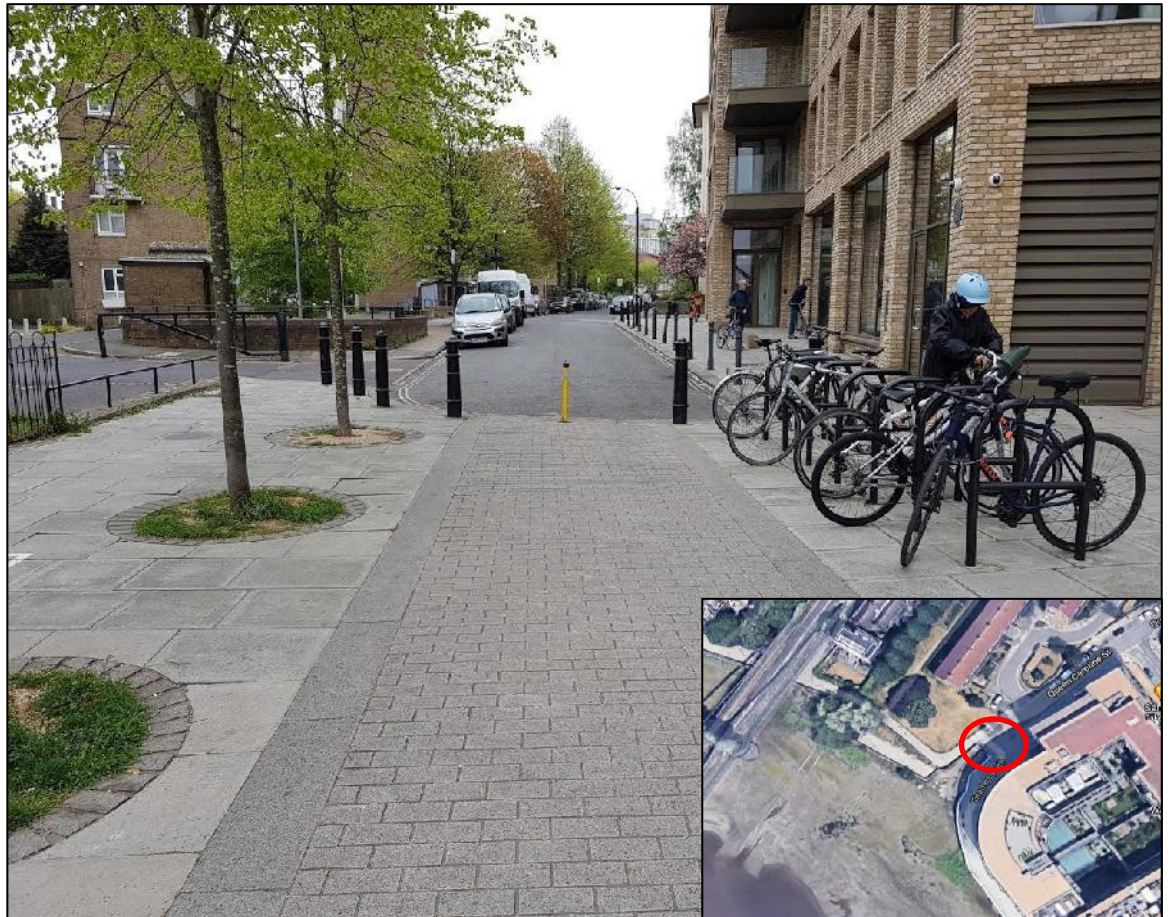
Figure 2-1: Proposed Landing Area for Hammersmith Pier Access Ramp

2.1.1 Figure 2-1 shows the existing landside of the area to be used for landing the Hammersmith Pier.

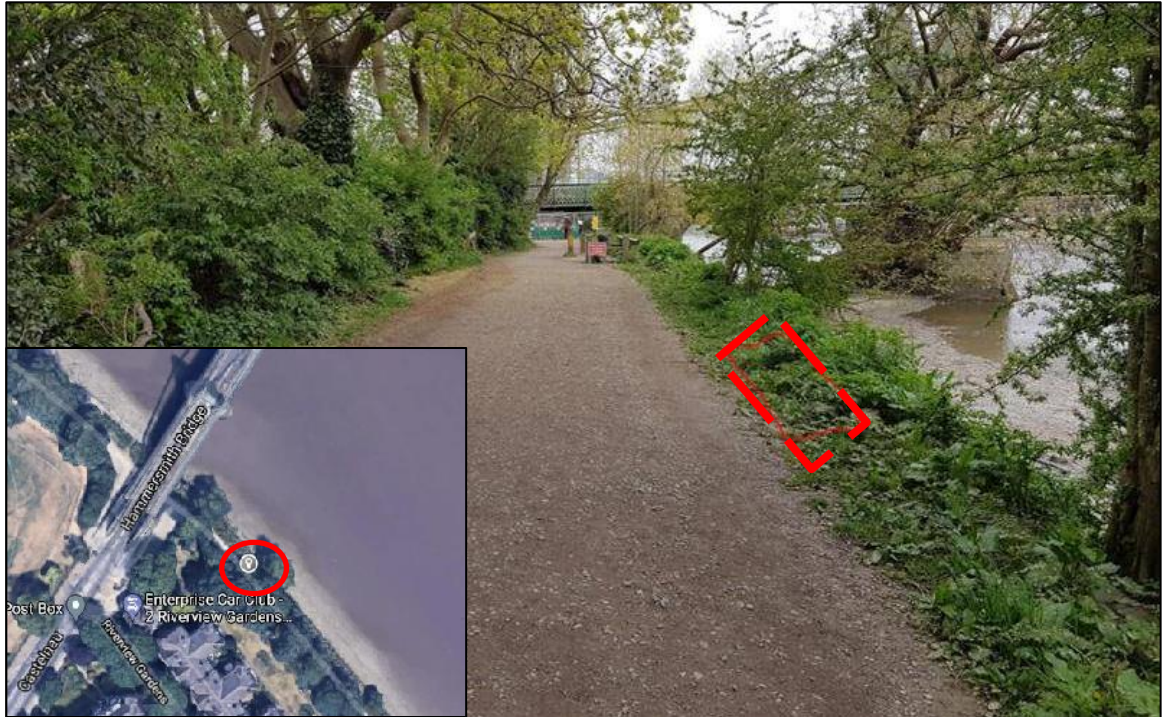
Figure 2-2: Proposed Landing Area for Barnes Pier

2.1.2 Figure 2-2 shows the existing landside of the area to be used for landing the Barnes Pier.

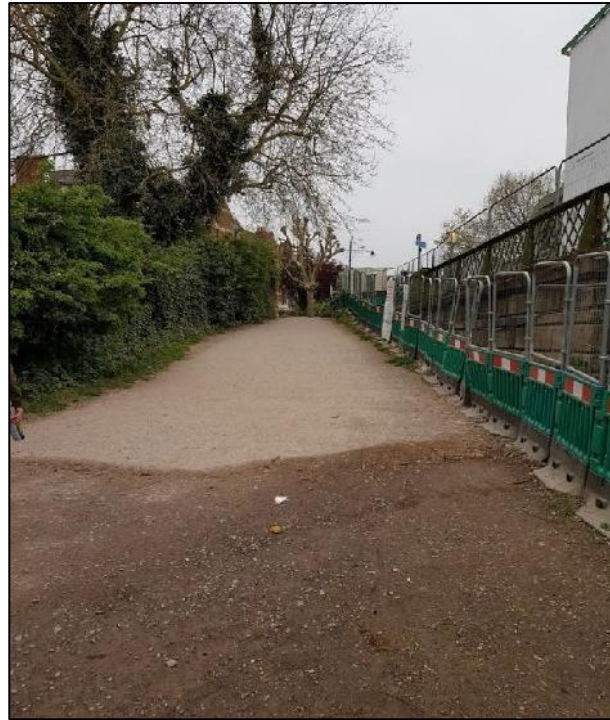
- 2.2.4 The landside works for Barnes Pier will involve installing a concrete base for the brow bearings, a raised walkway on the current embankment towpath and re-grading the slope to the side of Hammersmith Bridge.
- 2.2.5 The embankment towpath is located below Highest Astronomical Tide level and floods on large tides. As part of the works, a 45m long lightweight steel frame raised walkway will be installed to allow dry access to the pier. The clear width of this structure will be a minimum of 2.5m to suit segregated pedestrian and cycle traffic. The slope to the side of Hammersmith Bridge will be regraded to improve accessibility to the walkway. The slope consists of a gravelled path, an image of which is shown in Figure 2-3.

Figure 2-3: Concrete Path to the Side of Hammersmith Bridge

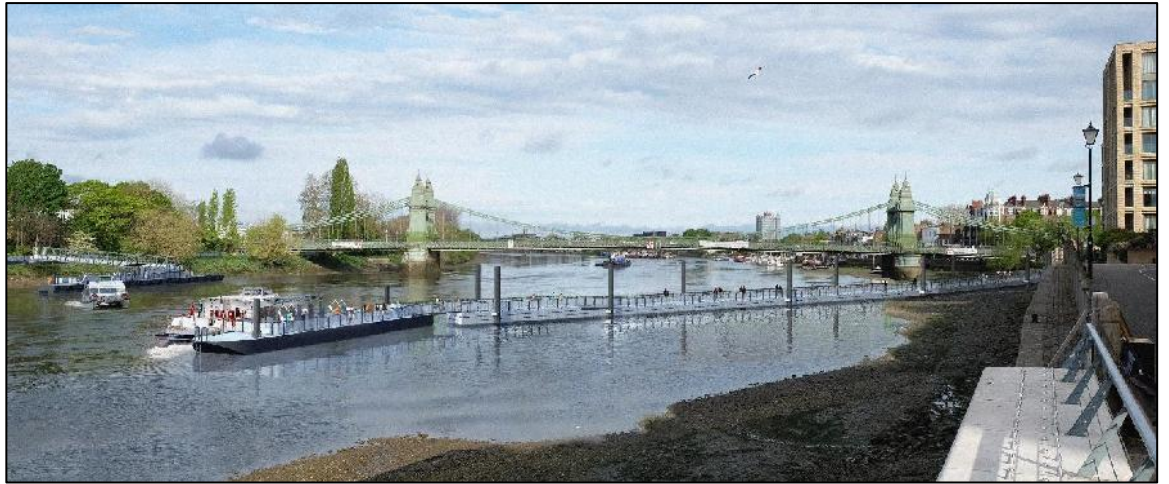
Figure 2-7: Proposed Hammersmith Temporary Pier CGI

2.4.5 As shown in Figure 2-7, during operation, the physical presence of the Hammersmith Temporary Ferry will affect the protected views to the historic Hammersmith Bridge from the East. However, this image also shows that, based on the pile heights, the bridge will still be predominantly visible at both high and low water from the northern bank. On the southern bank, the extent of the Barnes Pier is lesser meaning that only a small proportion of the bridge is covered (at all tides states) and the subsequent impact is therefore limited.

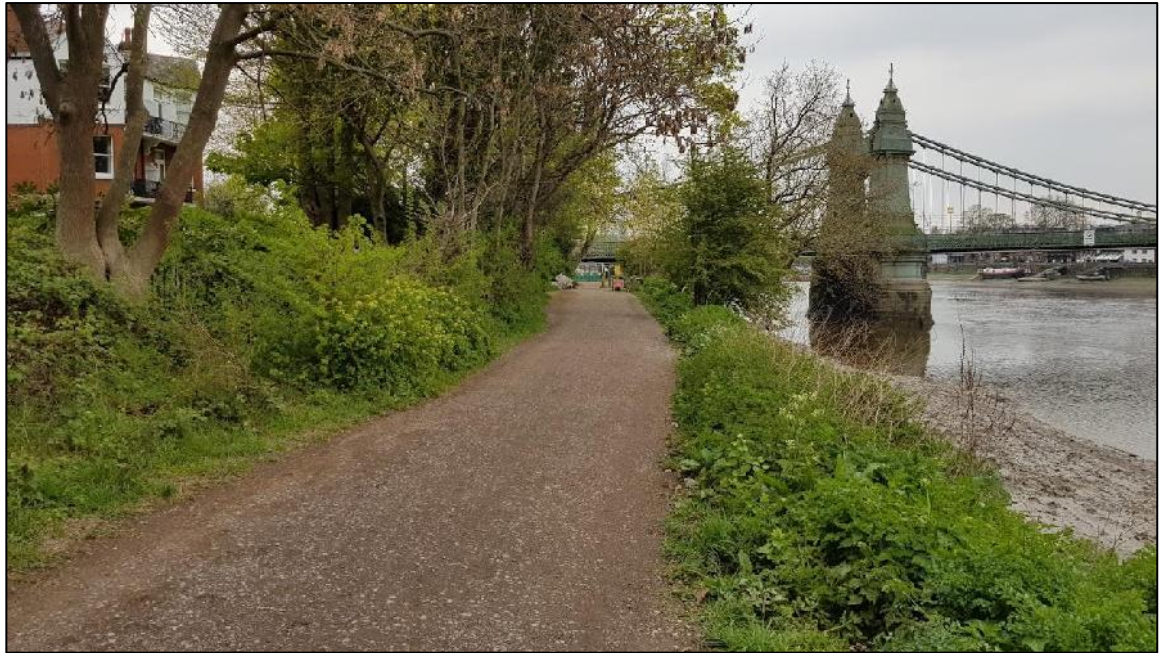
2.4.9 The other foliage on the Barnes footpath consists of low level scrub which can be seen in Figure 2-13. These plants do not have any arboricultural merit to constrain the development proposals.

Figure 2-13: Image of the Temporary Barnes Pier Towpath
