Barnes Green Study

Conservation Area No.1

SHOPFRONTS

Policies and Guidance

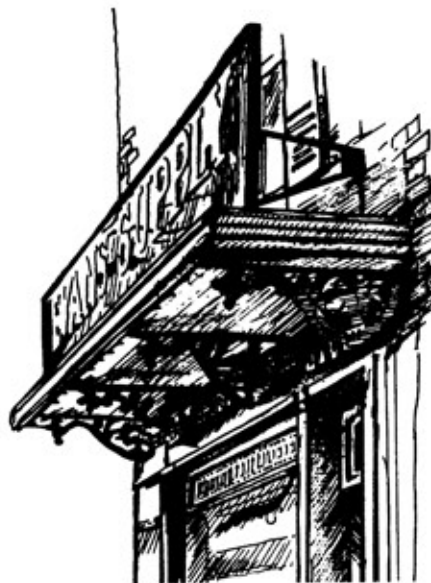
No 19 Barnes High Street

- No. 19** (BTM) an early Victorian shopfront of timber construction with a wide metal grille below fascia level, a flat timber fascia (modern applied lettering) and a canopy above, supported by decorative brackets. There is a simple stallriser, and plain pilasters framing both the window and entrance; these terminate at the fascia. The doorway is narrow and slightly recessed with a plain glazed fanlight above. The double door is formed of timber panels.

Nos. 19-23 represent a variety of shopfronts which have no cohesive elements. No. 19 has already been identified as suitable for retention and the other properties have a number of traditional elements with, in most cases, large parts of their original shopfronts remaining. All the properties would benefit from new paintwork, the removal of redundant features such as blind boxes and the removal of paint from tiled stallrisers and pilasters. Box and hanging signs need to be positioned on consoles and all unnecessary pipework removed from pilasters and fascias. The frontage of no. 19 would benefit from the removal of the first floor fascia sign and no. 21 is a possible location for a new shop front, or at least the installation of a shop window. The re-positioning of the existing consoles or provision of new wider corbels would balance the appearance of no. 23. Rigid blinds, or blinds of harsh coloured shiny materials would not be encouraged on this frontage and no. 19 would be unsuitable for any form of external blind.

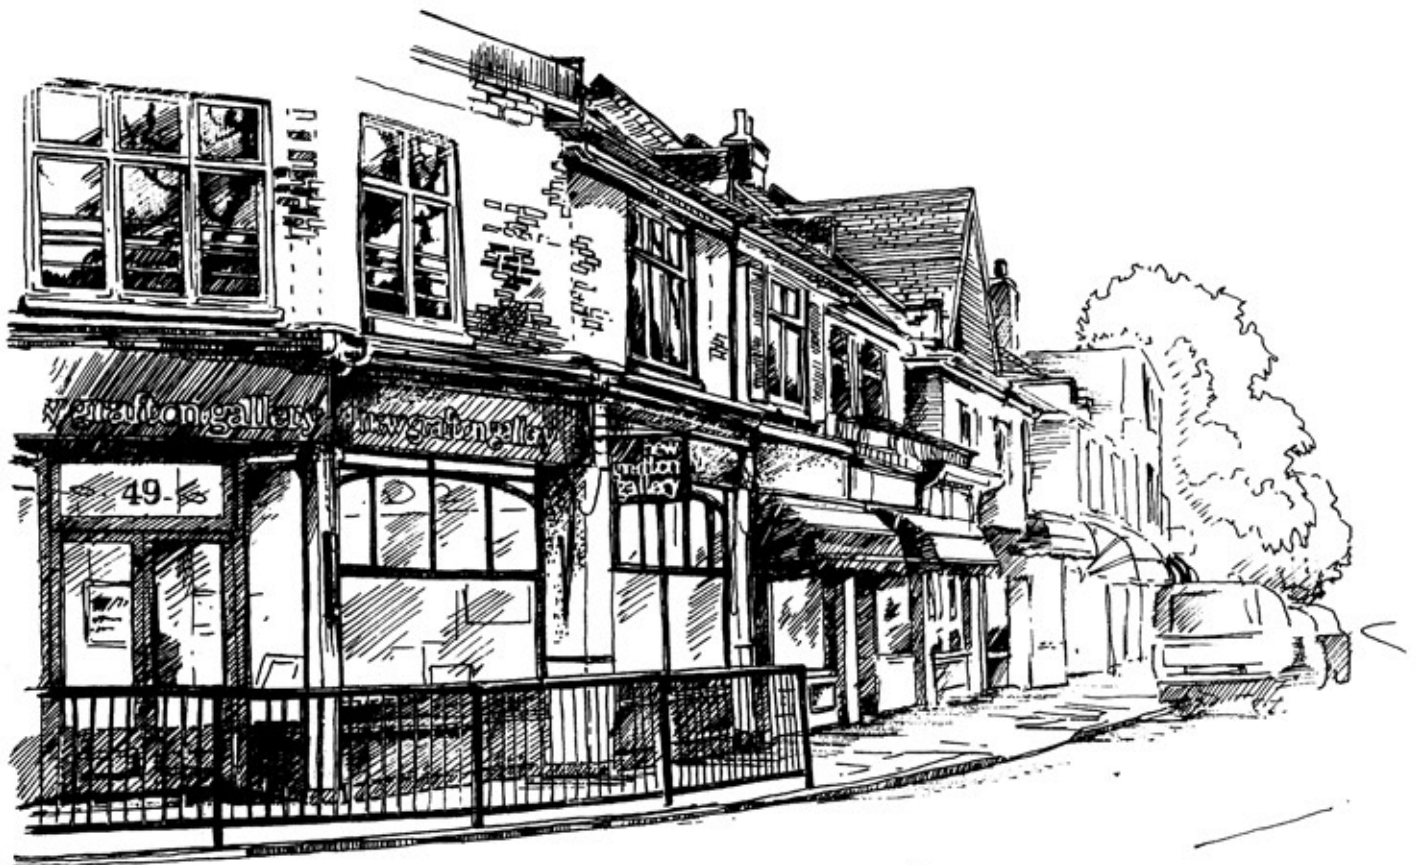
Church Road (western end)

This area consists of two terraces interspersed with modern development of a larger scale. The predominant features of the area's shopfronts are tiled pilasters and stallrisers, simple moulded corbels (two types), plain fascias and cornices, and in the case of nos. 49-65 cambered transoms.

For nos. 49-65 improvements should include the restoration of wood frames, reinstatement of cambered glazing bars, reintroduction of transoms and the simple vertical division of glazed areas in other properties. The removal of paint from stallrisers and the lower part of pilasters and restoration of tiled stallrisers throughout frontages would also be necessary. A number of fascias in the parade have been replaced. Applications for new fascias should

avoid shiny material and internally illuminated box signs. Acceptable replacements should follow the original fascia proportions and preferably be externally illuminated. The small scale of the shopfronts suggests that glazing bars should be slender with a raised profile so that wood, rather than coated aluminium, which has a heavy and flat appearance, would be preferable. A number of properties have rigid plastic Dutch blinds which are not in character with the Conservation Area. Where possible these should be removed altogether or replaced with traditional roller blinds. In many cases these, or at least the fittings for them, already exist and should be renovated and reused rather than ignored. Nos. 61-65 Church Road are of particular concern. The introduction of piers, consoles and a continuous fascia of regular proportions would unify this part of the terrace and render it less obtrusive.

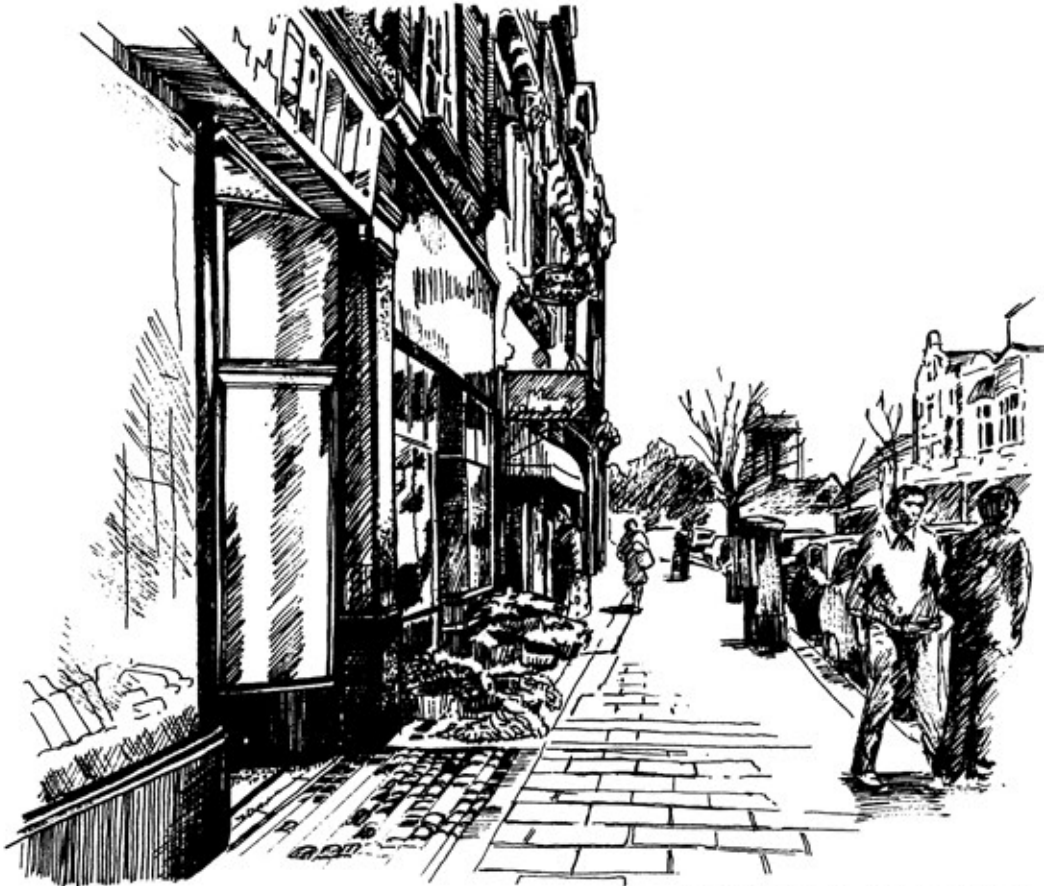
Church Road (eastern end)

This area consists of two terraces of similar design. The main cohesive elements of the frontages are the marble pilasters; these have a dark grey plinth with Greek key pattern decorative banding and a red upper portion decorated with a stylised cross motif. Nos. 54-64 have brown tiled surrounds. Throughout the frontages consoles are pronounced and all have simply moulded fluted detail; nos. 54-64 have a pediment above a plain frieze. Most of these properties have an angled fascia with a dentil course and cornice above. Many other shops have the same form of fascia with simple cornices above of similar dimensions. This adds to the overall unified appearance of the frontages. On the whole, shopfronts are of traditional design with timber frames, original glazing and recessed entrances, some with moulded ceiling details.

In general, pilasters need cleaning to remove paint and the remains of posters; corbels should be painted white or an agreed colour. The positioning of projecting box signs should be limited to the console only, and new projecting fascia boxes will be resisted. The original fascia dimensions must be observed in both terraces. Sub fascias will not be acceptable and down pipes running over consoles should be avoided, with those routed over fascias painted to match. All new shopfronts will be required to include a stallriser and recessed entrance. In both new and existing shopfronts the horizontal glazing division should be restored and glazing above the transom divided. Dutch blinds and blinds of shiny material will not be acceptable and should, where possible, be removed. Blind boxes should be placed below fascia level but above any glazed area and should be no wider than the shopfront. Alarms should be positioned to be inconspicuous or have a dark coloured cover.

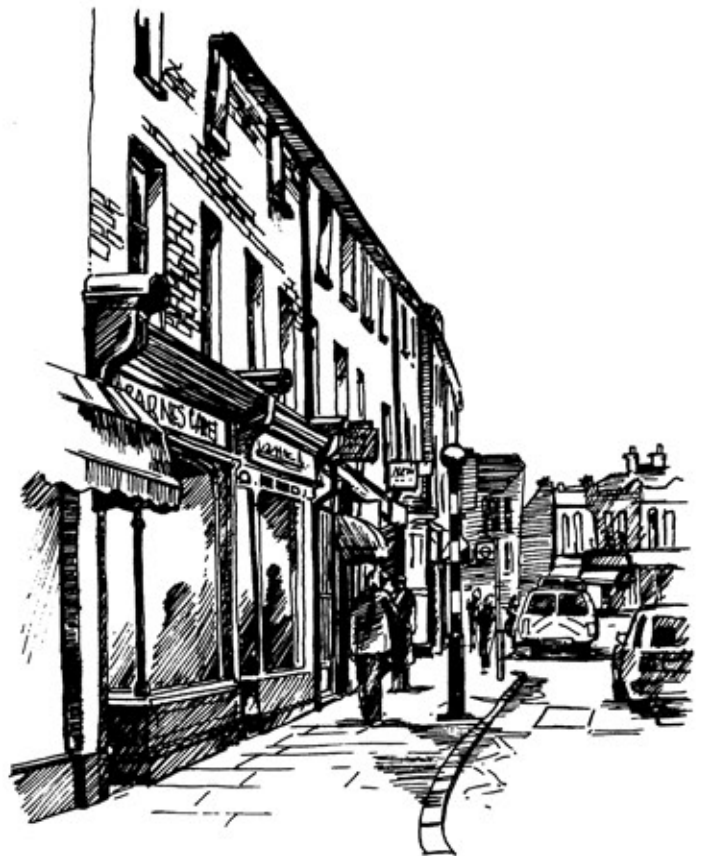
Barnes High Street

Description of elements to be retained

This is a small corner terrace situated at the western end of the High Street and no. 36A which has been identified as being of particular interest. The frontage has a continuous and complete framework of tiled pilasters with moulded consoles above; these have fluted detailing with a segmental pediment. The units also have continuous original entablature. Only one property has a modern replacement shopfront although the others have been modified to a certain extent. It is important that the features already described are retained together with the almost continuous stallriser. Although no. 34 appears to be a later shopfront than the others (apart from no. 36) it is very much a set piece. Its corner entrance and

The improvements required are of a minor nature such as the replacement of louvre glazing, the repositioning of projecting box signs and removal of inappropriate Dutch blinds. Fully glazed entrance doors throughout should be replaced by half, threequarters or full timber doors to avoid appearing flimsy. Tiled stallrisers should be reintroduced where possible and paint removed from similarly tiled pilasters; all corbels should be painted an agreed colour.
