## Hammersmith Temporary Ferry

### Detailed UXO Risk Assessment

Report Ref: 102963-PEL-GEN-ZZZ-SUR-RM-00002

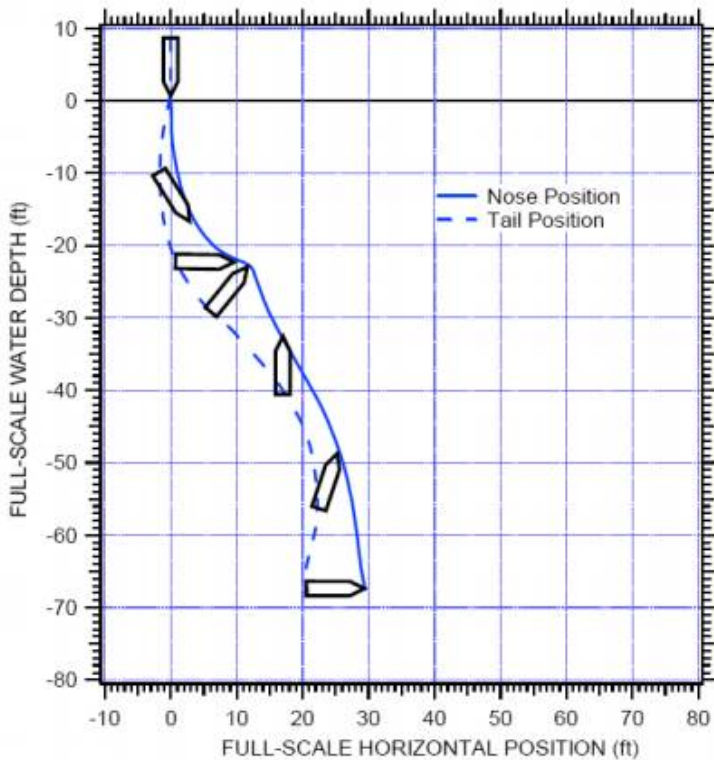
Within the section of the site occupied by river, the lowest possible water depth above the locations of the proposed works during WWII will also be considered.

For any part of the site located below the water mark of the lowest water level, calculating a maximum bomb penetration assessment is more problematic as the water column produces a decelerating effect that is not easily calculated.

Penetration into riverbed by bombs with a standard tangent Ogive nosecone is not well predicted as the bomb will deviate from its original path. The velocity at which a bomb is travelling becomes irrelevant in water deeper than several metres because the water has such a decelerating effect that a bomb will essentially “float” down to the seabed, however not necessarily in a vertical orientation; see graph (left) - plotting the trajectory of an American MK-84 (925kg) HE bomb with no tail section into water at an entry velocity of 296m/s.<sup>4</sup>

Taking into account the above-mentioned factors it has been assessed that a 500kg bomb would have had an approximate maximum bomb penetration depth of between **10-12m** below WWII ground level. Penetration depth could potentially have been greater if the UXB was larger (though only 4% of German bombs used in WWII over Britain were of that size). Note that UXBs may be found at any depth between just below the WWII ground level and the maximum penetration depth.

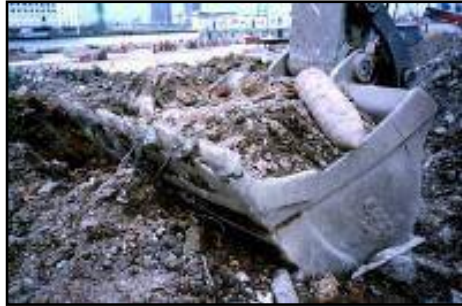
50kg bomb, London Docklands

50kg bomb, minus tail section

**Use:** Against lightly damageable materials, hangars, railway rolling stock, ammunition depots, light bridges and buildings up to three stories.

**Remarks:** The smallest and most common conventional German bomb. Nearly 70% of bombs dropped on the UK were 50kg.

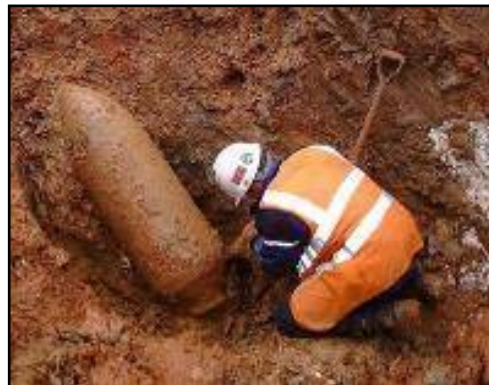
250kg bomb, Hawkinge

**Use:** Against railway installations, embankments, flyovers, underpasses, large buildings and below-ground installations.

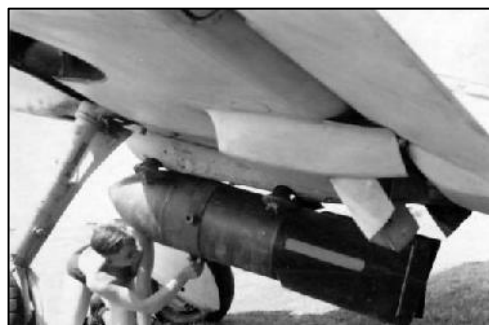
SC250 attached to undercarriage of Messerschmitt Bf109

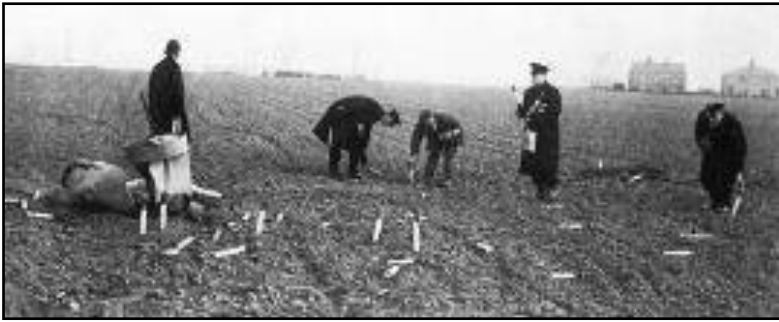
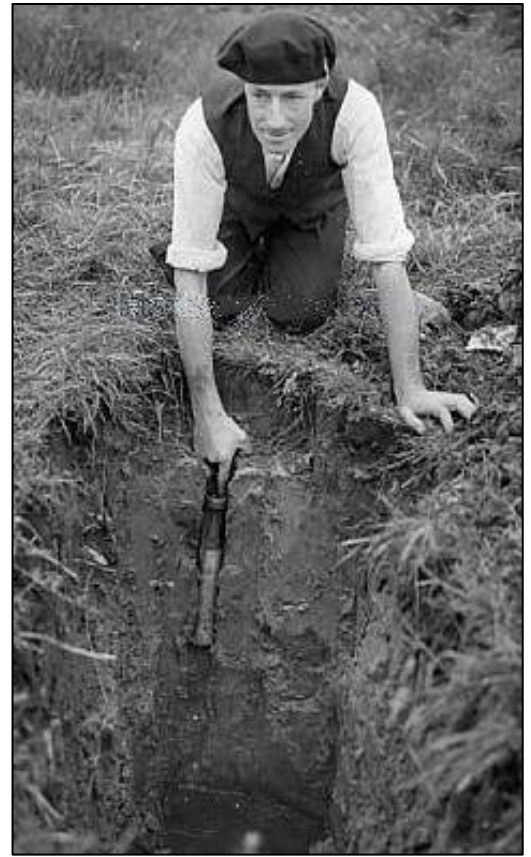
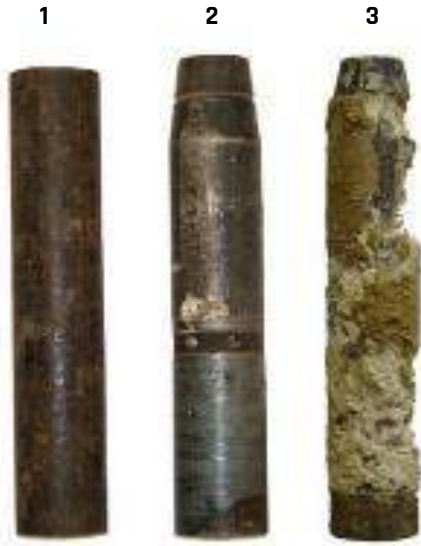
1. Ordinary scaffold pipe
2. 1kg incendiary bomb
3. Incendiary bomb recently found on site in UK

**Use:** As incendiary - dropped in clusters against towns and industrial complexes

**Remarks:** Jettisoned from air-dropped containers. Magnesium alloy case. Sometimes fitted with high explosive charge

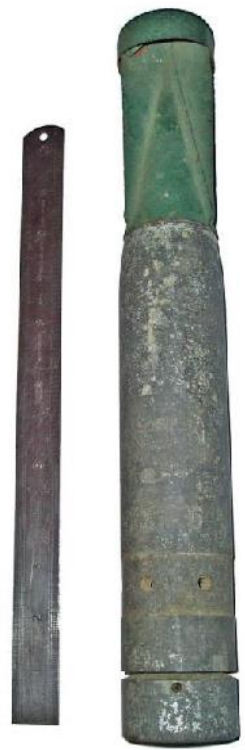
1kg German Incendiary Bomb next to a 30cm ruler

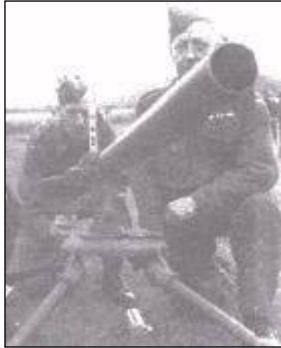
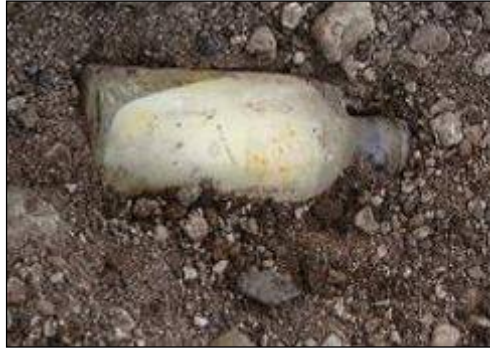
## Self Igniting Phosphorous (SIP) Grenades

The grenade comprised a glass bottle with a total volume of approximately one pint. It was filled with White Phosphorus, benzene, a piece of rubber and water. Over time the rubber dissolved to create a sticky fluid which would self ignite when the bottle broke. Fired by hand or Northover Projector. Sometimes called the "A & W" (Albright & Wilson) grenade.

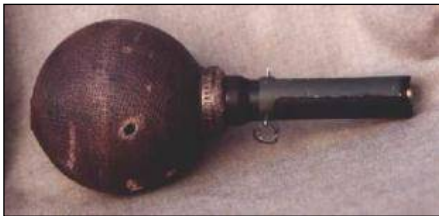
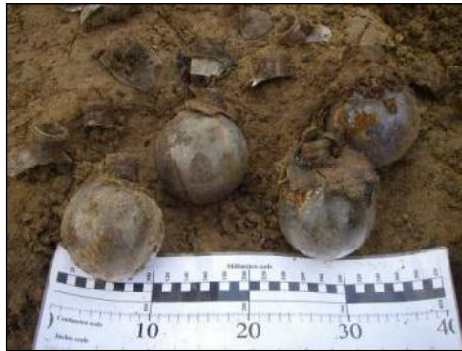
## No 74 Grenade (Sticky Bomb)

Designed as an anti-tank grenade and used by the Home Guard. The grenade consisted of a glass ball on the end of a Bakelite (plastic) handle. Inside the glass ball was an explosive filling whilst on the outside was a very sticky adhesive covering. Until used, this adhesive covering was encased in a metal outer casing.

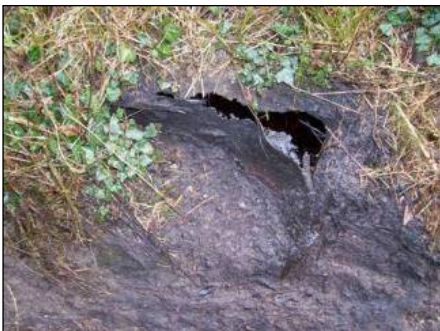
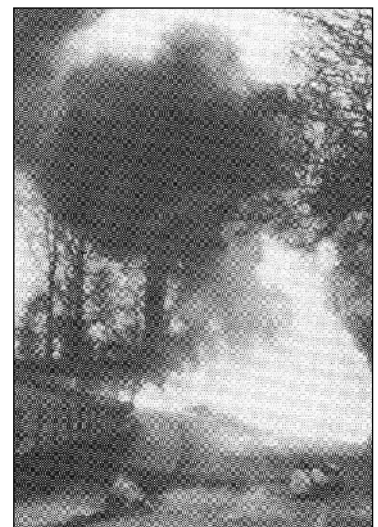
## Flame Fougasse Bomb

A Flame Fougasse was a weapon in which the projectile was a flammable liquid, typically a mixture of petrol and oil. It was usually constructed from a 40-gallon drum dug into the roadside and camouflaged. Ammonal provided the propellant charge which, when triggered, caused the weapon to shoot a flame 3m (10ft) wide and 27m (30 yards) long. Initially a mixture of 40% petrol and 60% gas oil was used, this was later replaced by an adhesive gel of tar, lime and petrol known as 5B.

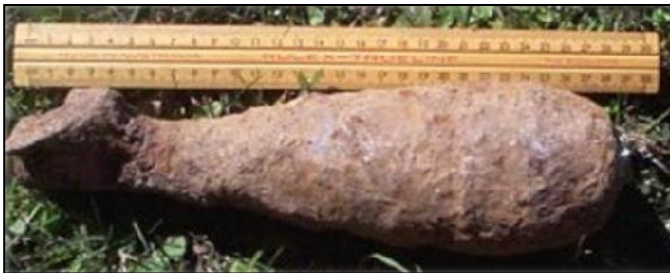
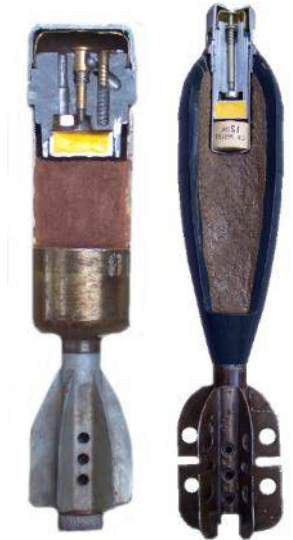
### Typical 3 inch Smoke Mortar

- Type: Smoke
- Dimensions: c490 x 76mm (19.3in x 3in)
- Filling: Typically white phosphorous
- Maximum Range: 2515m (2,750yds)
- Remarks: On impact, the fuze functions and initiates the bursting charge. The bursting charge ruptures the mortar bomb body and disperses the white phosphorous filler. The white phosphorous produces smoke upon exposure to the air.

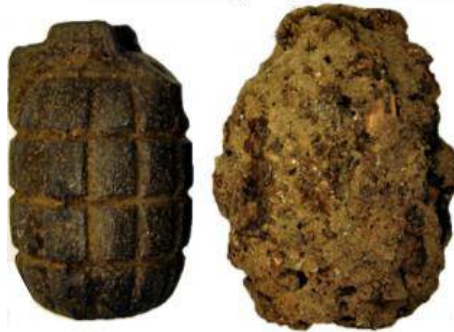
## No. 36 'Mills' Grenade

Weight: 0.7kg filled (1lb 6oz)  
Type: Hand or discharger, fragmentation  
Dimensions: 95 x 61mm (3.7 x 2.4in)  
Filling: Alumaton, Amatol 2 or TNT  
Remarks: 4 second hand-throwing fuse with approximate 30m range. First introduced May 1918.

Grenade, .303 inch rifle, No. 36M, Mark I.

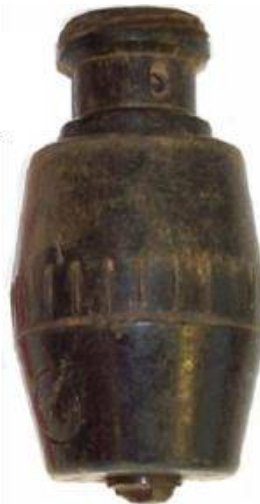
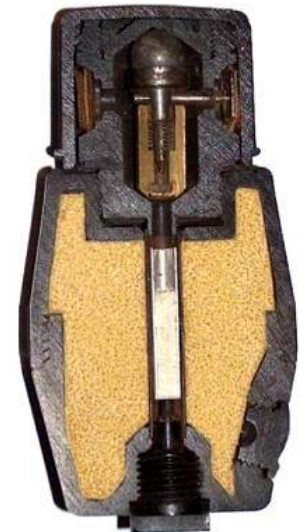
## No. 69 Grenade

Weight: 0.38kg filled (0.8lb)  
Type: Percussion/Blast  
Date Introduced: December 1940  
Remarks: Black Bakelite body. Blast rather than fragmentation type. After unscrewing the safety cap, a tape is held when throwing the grenade releasing the safety bolt in the throwing motion. Detection is problematic due to its very low metal content.

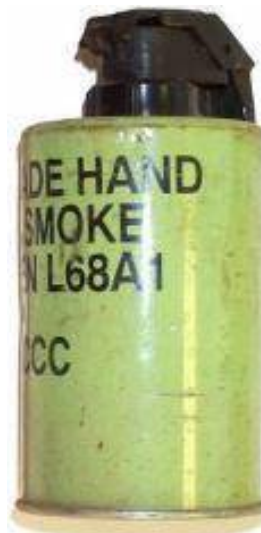
## Typical Smoke Grenade

Dimensions: Approx. 65 x 115mm (2.5 x 4.5in)  
Type: Smoke  
Date Introduced: Current MoD issue  
Remarks: Smoke grenades are used as ground-to-ground or ground-to-air signalling devices, or landing zone marking devices, and screening devices for unit movement.

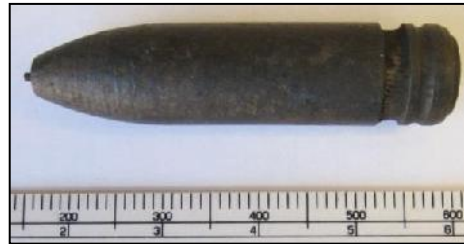
### 20mm Hispano HEI Ammunition

- Type: Live canon round
- Markings: Upper half of projectile pointed 'buff' colour, lower half is red.
- Cartridge Weight: 256 grams
- Dimensions: Total cartridge / projectile length - 182mm
- Fuzed: Contact fuze - No.253, No.254 or No.917
- Filling: 108 grains of contact explosive + 68 grains of SR.379 incendiary composition.
- Threat: Explosives within unspent cartridge as well as the projectile.
- Deployment: Royal Navy, RAF and British Army Light Anti- Aircraft guns. Also RAF aircraft canons.
- Remarks: Cartridges are belted or supplied lose in cartons.

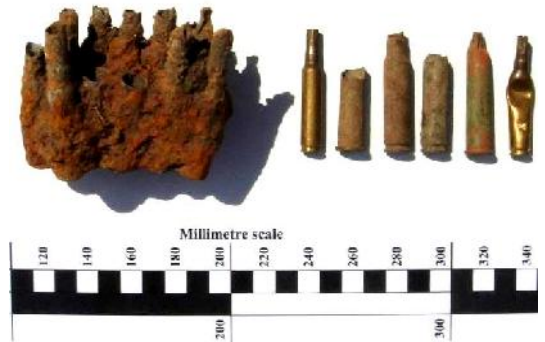
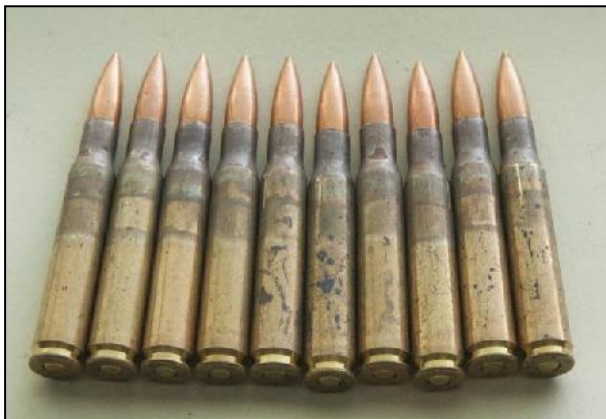
### .303" Ammunition

- Type: Rifle / machine gun round
- Markings: Regular round - none. Tracer round - red Primer
- Bullet Weight: 150 - 180 grams
- Dimensions: Total cartridge /projectile length - 78mm
- Filling: Regular round - none. Tracer round - small incendiary fill
- Threat: Explosive cordite within unspent cartridge
- Deployment: Royal Navy, RAF and British Army Light Anti-Aircraft guns, machine guns and rifles. Standard British and Commonwealth military cartridge from 1889 until the 1950s.
- Remarks: Cartridges are belted or supplied lose in cartons.

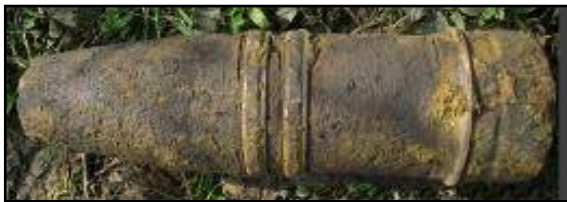
3.7 inch AA Projectile, Minus Fuze.

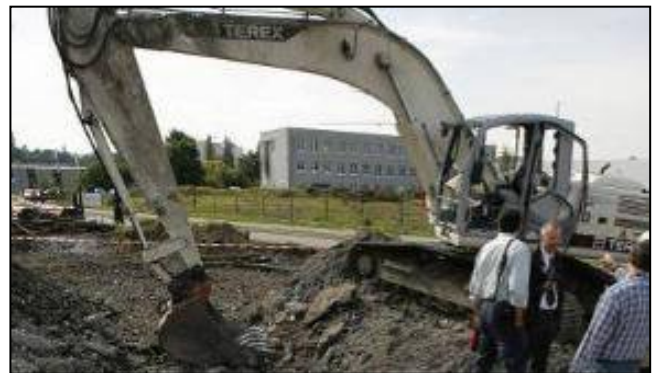
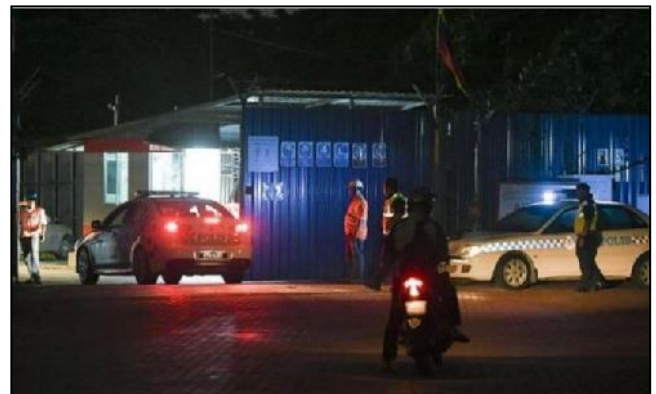
**Bottom Right:** A buried WWII-era bomb exploded during construction works in Bandar Malaysia, Kuala Lumpur - 2017.

I dead, 2 critical after explosion at Malaysia MRT construction site caused by WWII bomb

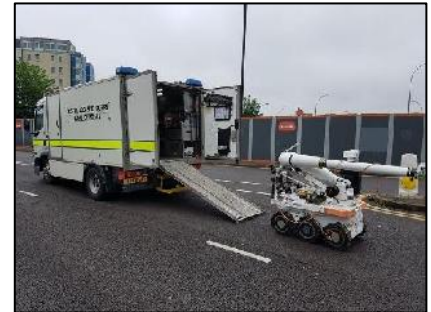
### Unexploded WW2 bomb found in Birmingham

An unexploded Second World War bomb was found in Birmingham this afternoon, causing a construction site to be evacuated.

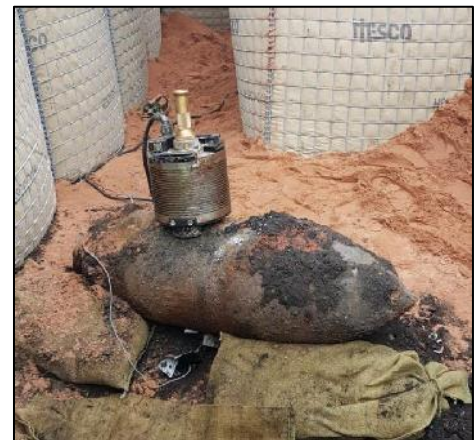
### Aston Expressway bomb: Controlled explosion carried out on Second World War shell

A Second World War bomb found near the Aston Expressway has been safely detonated, bringing 30 hours of drama to an end. The explosion meant a gradual return to normality for the 200 residents who had been evacuated from the 1,600ft (500 metre) cordon put in place on the advice of explosives experts.

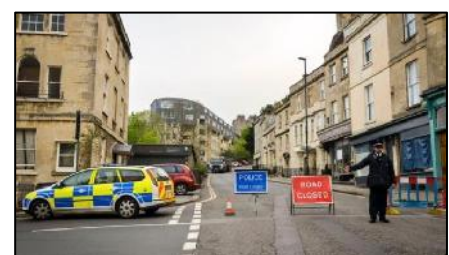
### Bath WW2 bomb scare: Hundreds of homes evacuated

Up to 1,000 homes have been evacuated and a 300m exclusion zone is in place following the find in Lansdown Road.

According to reports, a 500lb (228kg) bomb was found just a metre beneath a playground at the former Royal High Junior School.
